Safety Recall

Code: 97EV

Subject Engine Control Module (ECM) Connector

Release Date March 04, 2021

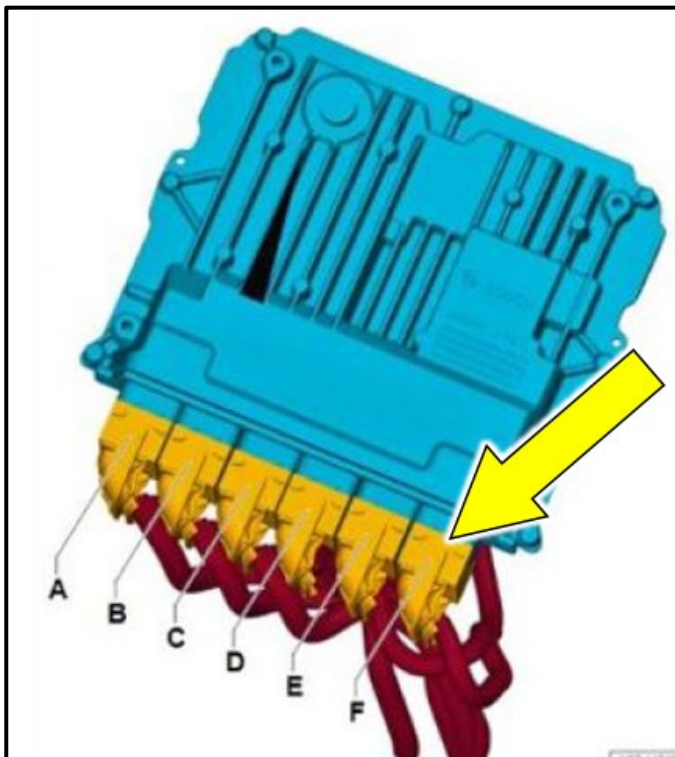
Inspect ECM and T56f connector:

If the sealing pin was missing from position 19 (T56f/19), it's possible that moisture entered the ECM connector and caused corrosion.

- Turn off ignition.
- Disconnect T56f connector <arrow>.

- Check ECM pins and T56f connector for corrosion.
- If corrosion is found:
 - A new sealing pin must be installed in the T56f connector.
 - The ECM must be replaced.
 - Any corroded pins in the T56f connector must be replaced.
- If no corrosion is found:
 - A new sealing pin must be installed in the T56f connector.
