VSR-TSB-031

NHTSA Campaign Number: 21V-125

# Vehicle Safety Recall - Technical Service Bulletin

**Attention:** Oshkosh Product Owner  
**Subject:** Dana Axle Output Shaft  
**Models Affected:** Oshkosh S-Series Front Discharge Mixer  
**Model Year:** 2020-2021  
**Date:** March 2021

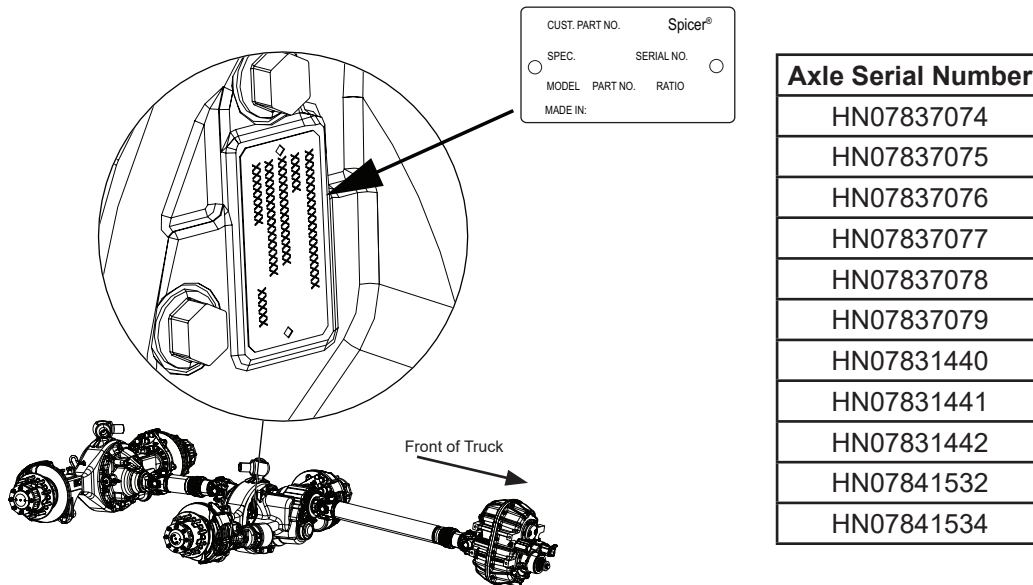
3. Locate the axle identification tag on the forward drive axle, See Figure 1.

If the axle serial number matches one of the serial numbers in the Figure 1 table continue to Step 4.

If the axle serial number does not match one of the serial numbers in the Figure 1 table axle inspection is complete and no further action is required.

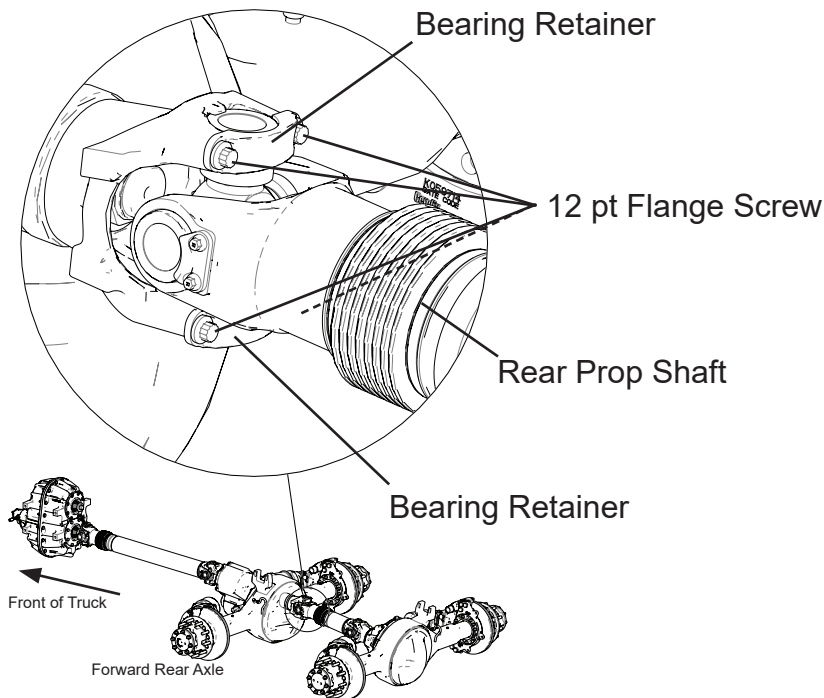
Figure 2

4. Remove the four 12 point flanged screws securing the two bearing retainers to the forward rear drive axle output shaft yoke, see Figure 2.

5. Disconnect the rear prop shaft from the forward rear drive axle output shaft yoke, see Figure 2.

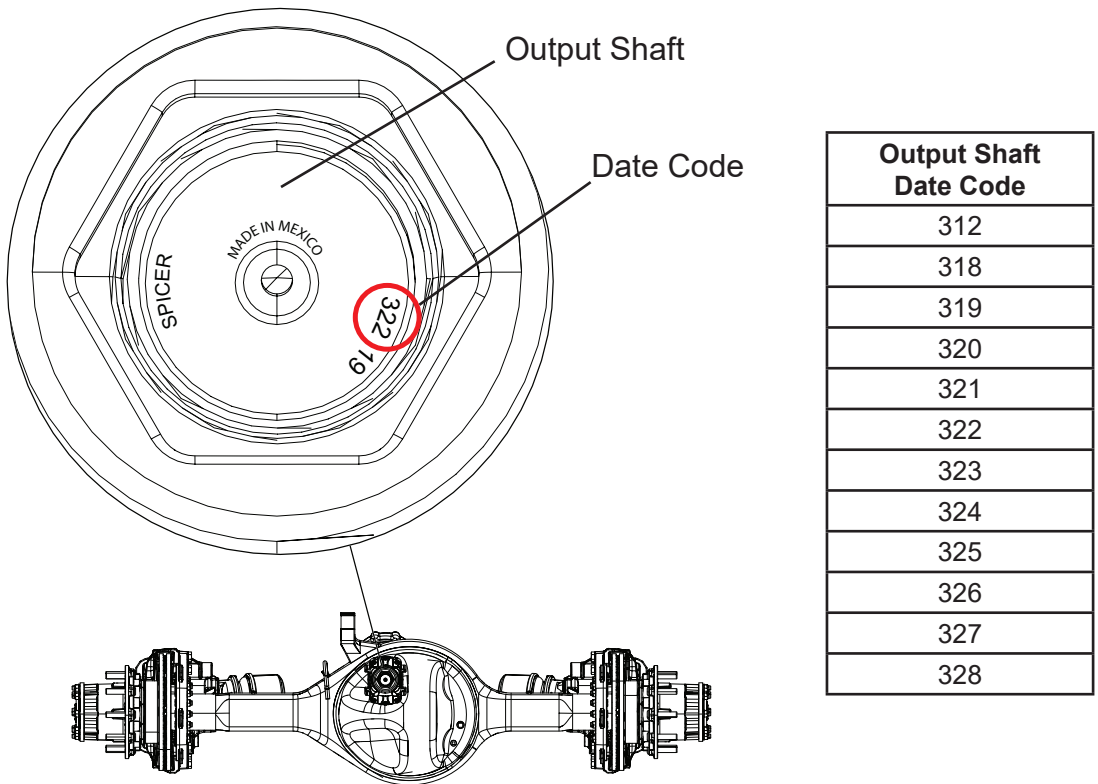
6. Clean off the end of the forward rear drive axle output shaft, see Figure 3.

7. Locate the date code stamped on the end of the output shaft, see Figure 3.

If the date code stamped in the end of the output shaft is listed in the Figure 3 table contact Dana Warranty/Service at 877-777-5360 for information on replacing the output shaft.

If the output shaft does not include a date code listed in the Figure 3 table go to Step 8.

8. Reinstall the rear propshaft onto the forward rear drive axle output shaft yoke.
9. Reinstall the two bearing retainers and four 12 point flanged screws. Final tighten screws to 115-125 ft. lbs.
10. Remove lockout/tagout.
