**AMA2 - Replacing Seat Occupancy Detection System for Passenger Seat (USA/Canada)
(Recall Campaign)**

Revision: This bulletin replaces bulletin Group 6 50/21 AMA2, dated September 28, 2021.

Model Line: **Macan**

Concerns: **Seat occupancy detection system for passenger seat**

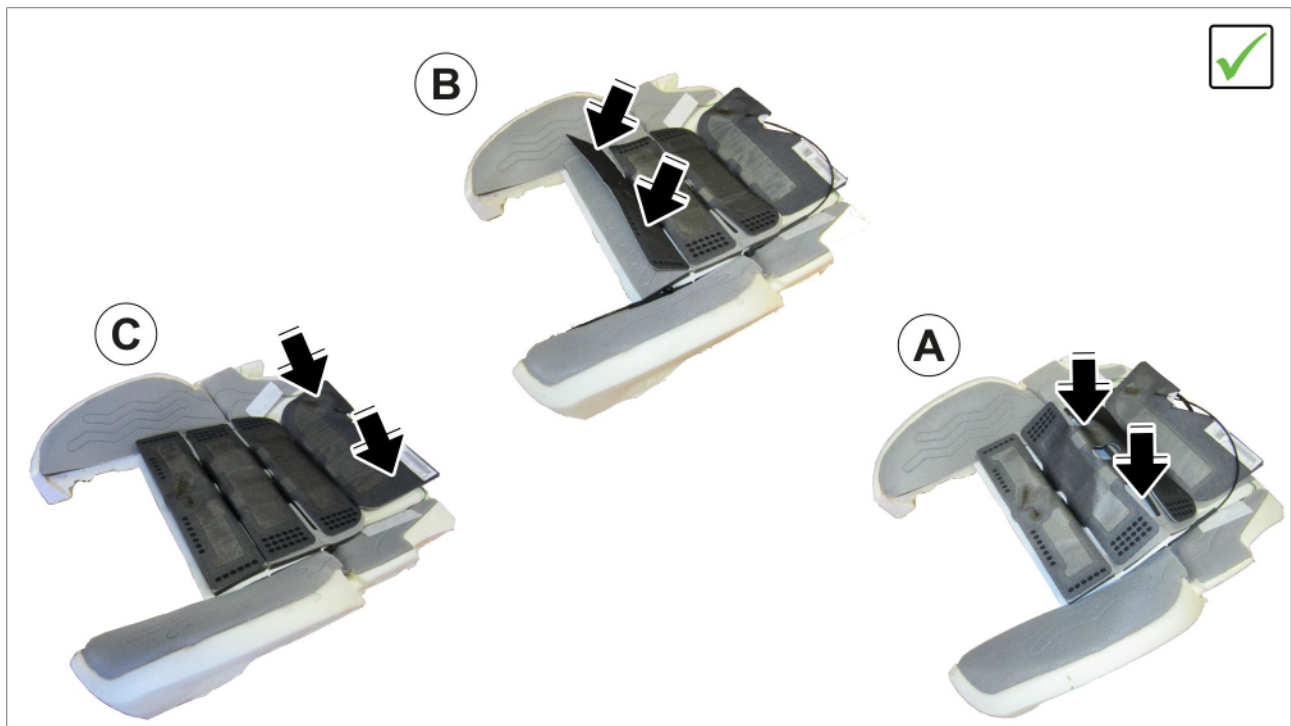
Overview of padding

Between delivery of the padding to its installation in the front seat, the glued sensor mat can partially detach from the foam part over longer periods of time. This does not constitute a material defect and will have no influence on the quality of the sensor mat.

If the sensor mat has come loose as shown in the picture, then the sensor mat must be pressed back in place before installation as shown in pictures A, B, C.
 Complete adhesive strength is only achieved after attaching or clamping the seat cover.

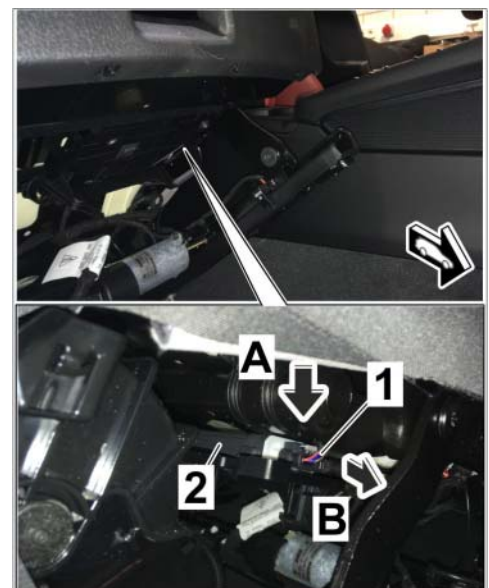
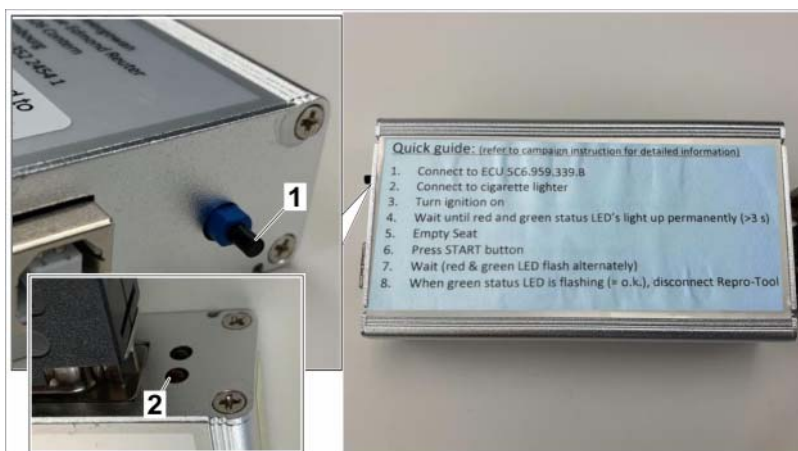
Re-programming control unit

- 1 – Start button
- 2 – LED display

- 6.5 Unlock the secondary locking of the plug connection ⇒ *Re-programming control unit -1-* on the occupant detection control unit ⇒ *Re-programming control unit -2-* (⇒ *Re-programming control unit -arrow A-*) and unplug the plug ⇒ *Re-programming control unit -arrow B-*.

- 6.6 Connect the cable set for the programming box to the occupant detection control unit and to the cigarette lighter in the centre console.
 - 6.7 Switch on the ignition and reprogram the occupant detection control unit in the vehicle according to the instructions on the programming box.
