RECALL CAMPAIGN BULLETIN

Classification: EL21-007	Reference: NTB21-026	Date: March 29, 2021
-----------------------------	-------------------------	-------------------------

VOLUNTARY SAFETY RECALL CAMPAIGN 2016-2019 SENTRA; STOP LAMP SWITCH REPLACEMENT

CAMPAIGN ID #: PM971
APPLIED VEHICLES: 2016-2019 Sentra (B17)

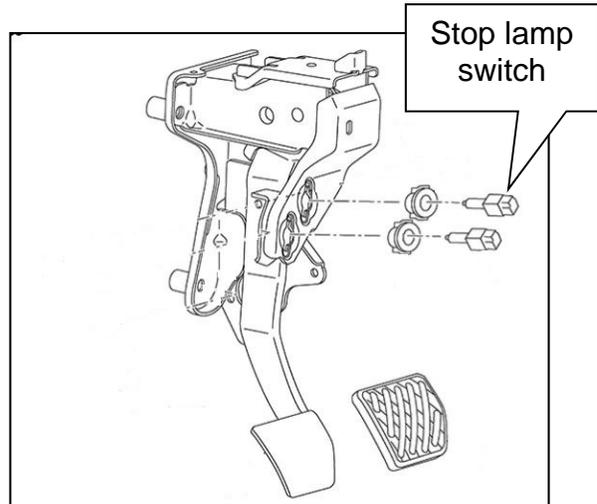
Figure 4

HINT: The stop lamp switch is the upper of the 2 switches, as shown in Figure 4.

8. Rotate the stop lamp switch counterclockwise to remove.

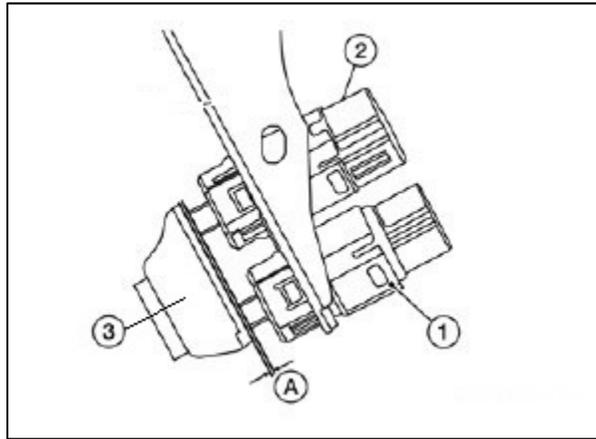
Figure 11

IMPORTANT: Make sure that the clearance (A) between the brake pedal (3) and the brake pedal position switch (1) and the stop lamp switch (2) are within specification. The brake lights must turn OFF when the brake pedal is released.

- Clearance (A): 0.74 – 1.96 mm (**0.03 – 0.08 in.**)

15. Adjust the stop lamp switch.
