# RECALL CAMPAIGN BULLETIN

| Classification:<br>EL21-007B | Reference:<br>NTB21-026B | Date:<br>September 9, 2021 |

## VOLUNTARY SAFETY RECALL CAMPAIGN 2016-2019 SENTRA; STOP LAMP SWITCH REPLACEMENT

**CAMPAIGN ID #:** PM971  
**APPLIED VEHICLES:** 2016-2019 Sentra (B17)

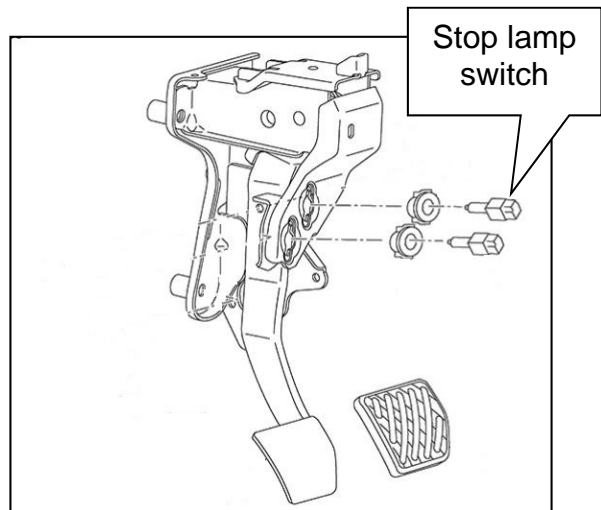
Figure 1

**HINT:** The stop lamp switch is the upper of the 2 switches, as shown in Figure 1.

2. Disconnect the harness connector from the stop lamp switch.
3. Rotate the stop lamp switch counterclockwise to remove.

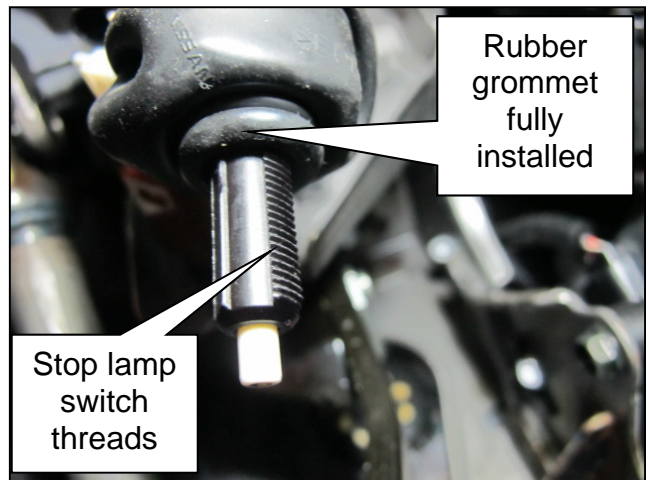
Figure 4

**NOTE:** When the rubber grommet is fully installed, the threads of the stop lamp switch will be exposed (Figure 4).

6. Pull the large opening of the rubber grommet to completely cover the stop lamp switch and harness connector.

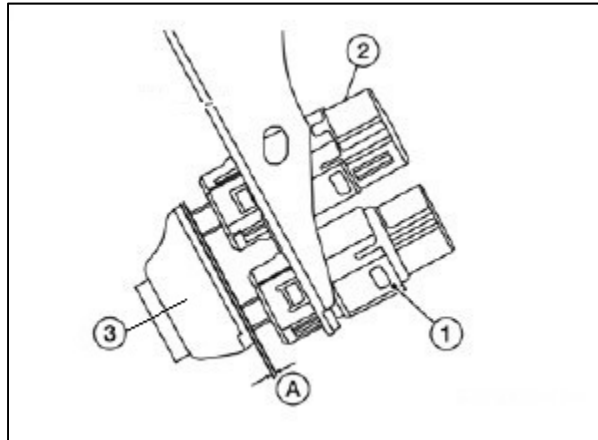
Figure 8

**IMPORTANT:** Make sure that the clearance (A) between the brake pedal (3) and the brake pedal position switch (1) and the stop lamp switch (2) are within specification. The brake lights must turn OFF when the brake pedal is released.

- Clearance (A): 0.74 – 1.96 mm (0.03 – 0.08 in.)

10. Adjust the stop lamp switch.

- For stop lamp switch adjustment, refer to the ESM section below.
  - **BRAKES > BRAKE SYSTEM > PERIODIC MAINTENANCE > BRAKE PEDAL > ADJUSTMENT > STOP LAMP SWITCH AND BRAKE PEDAL POSITION SWITCH**
