# Safety Recall Code: 70i2

Passenger Airbag - Score Line

March 19, 2021

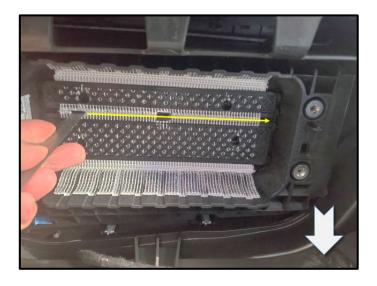
- · Remove passenger frontal airbag.
- Check netting in instrument panel and repair netting, if necessary.

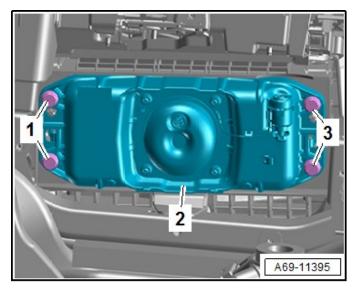
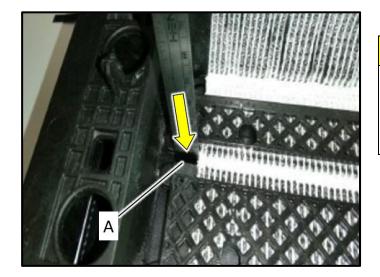
## Check airbag flap netting in instrument panel:

The netting in area <1> will be reworked.

- Secure the airbag from falling.
- Remove the bolts <1 and 3>.
- Remove the airbag <2> downward.

Insert the rounded end of the ruler into opening
 A> on the left side of the netting.
