A. VEHICLE INSPECTION PROCEDURE

REPAIR OUTLINE

B. REPAIR PROCEDURE

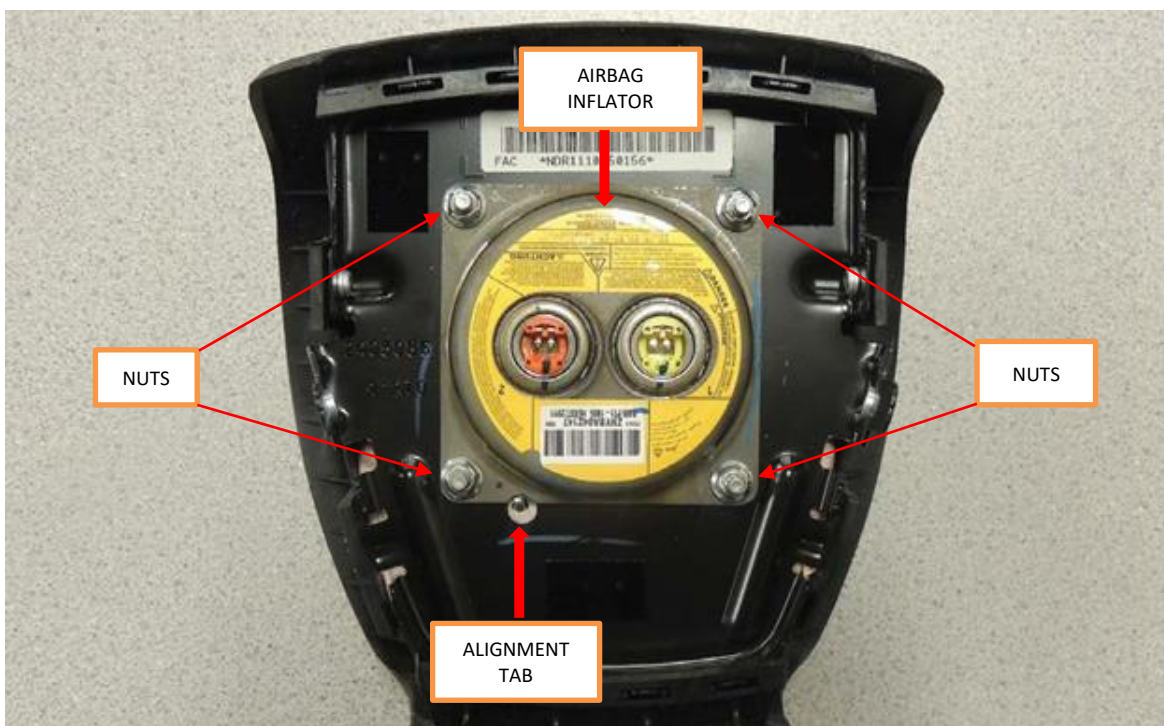
FIGURE 1

1. Remove and discard the 4 airbag inflator retaining nuts from the driver side airbag. See Figure 1. **Do not use any sort of Power Tool!**

- Remove the airbag inflator and set aside for return shipping. See Figure 1

Install the *new* inflator into the driver airbag. Verify the alignment tab on the airbag housing is aligned with the cut-out on the inflator. See Figure 1

4. Install 4 *new* airbag inflator nuts onto the driver airbag. See Figure 1. **Do not use any sort of power-tool to install these nuts under any circumstance.**
 - Tighten to **57 in-lb** (6.5 Nm). **This less than 5 ft-lbs!**
5. Re-install the driver airbag
 - a. Install the driver air bag module. Refer to MGSS online ([DRIVER AIR BAG MODULE REMOVAL / INSTALLATION](#)).
 - b. Reconnect the negative battery cable.
 - c. Turn the ignition switch to the ON position.
 - d. Verify that the air bag system warning light illuminates for approx. 6 sec., then goes out.
 - e. **NOTE:** If the air bag system warning light does not operate in the manner described above, there is a malfunction in the system. Inspect the system following the on-board diagnostic system procedure according to MGSS.
 - f. Re-enter the customer's preset radio stations
