SERVICE BULLETIN INSTRUCTIONS FOR RECALL 26V-166

Date: March 31, 2021

Topic: Inspection and replacement of suspected defective Bendix SL-4 Stop Light switches.

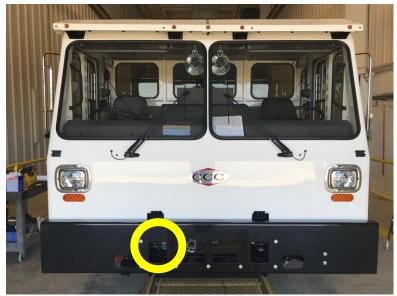
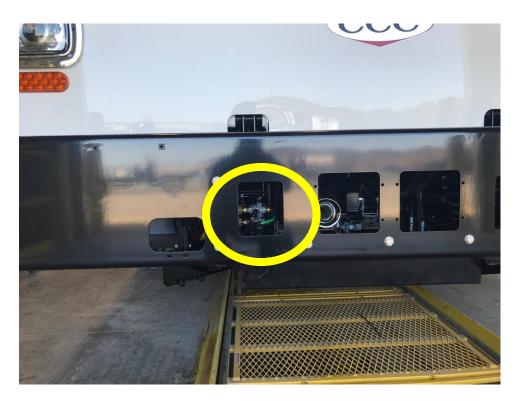
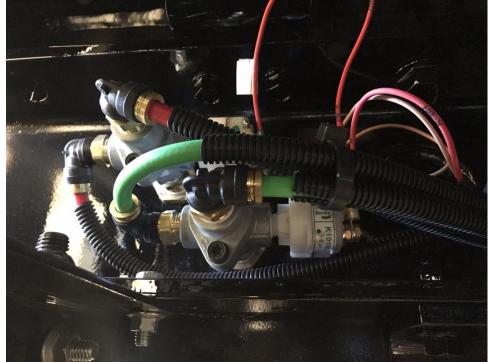
2. Locate the stop light switches located on the double check valves, under the right-hand side of the cab on the inside of the frame rail.

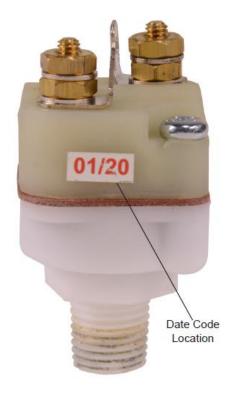
3. Inspect the switches to determine if the date code can be found, and if it is shown as "12/19" or "01/20". The Bendix® SL-4TM stop light switch includes a date code printed on a white Bendix label affixed to the unit. The date code, featuring a "Month/Year" format, appears in red type. Stop light switches covered by this campaign would have a date code of either 12/19 or 01/20. For example, an SL-4 stop light switch manufactured in December of 2019 will have a date code of "12/19" in red type, and an SL-4 stop light switch manufactured in January of 2020 will have a date code of "01/20" in red type. Verification of the date code is required to determine if the stop light switch is a part of the recall campaign.

- 4. If the date code can be determined and is not in the specified range, no further action is required. If one or both switches is within the specified range, proceed to step 5.
- 5. Remove the two wires from the suspect switch. Remove the switch from the manifold utilizing the appropriate size wrench.
- 6. Reinstall the new switch utilizing the reverse procedure from step 5.
- 7. Verify the operation of brake lights by building up a minimum of 120 psi air pressure, release the parking brakes, and applying the service brakes. Brake lights should come on with the service brakes applied and go off with the service brake released. Ensure the wheels are chocked before releasing the parking brake.
