RECALL CAMPAIGN BULLETIN

VOLUNTARY SAFETY RECALL CAMPAIGN 2020 MURANO; TRANSVERSE LINK INSPECTION AND REPLACEMENT

CAMPAIGN ID #: PC797

APPLIED VEHICLES: 2020 Murano (Z52)

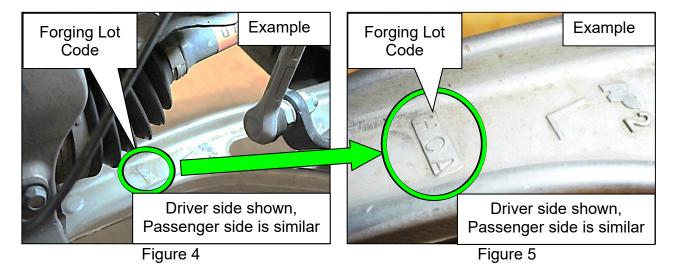
4. Locate the 3-digit Forging Lot Code on the top side of the driver side and passenger side TV link (Figure 4 and Figure 5).

Are the first 2 digits of the Forging Lot Code one of the following listed below?

> Driver Side: **GF**

Passenger Side: GH or GL

o YES: Continue to step 5 to replace the affected TV link(s).

o **NO:** Do <u>NOT</u> replace the TV link(s). Skip to step 6 on page 4 to install the wheel and tire assemblies.
