64/21 ENU AMA8

AMA8 - Reworking Threaded Joints of the Shock Absorbers on the Front and Rear Axles (Stop Delivery/Stop Use/Recall Campaign)

Model Line: Macan (95B)

Model Year: 2021

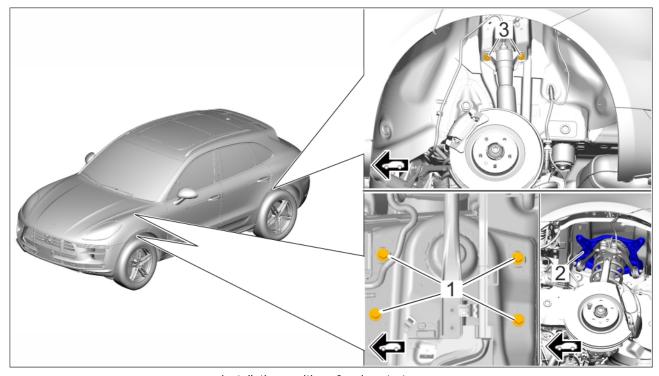
Installation position of spring strut screws

Information: Due to a failure in the software of the screwdriver in vehicle production, the screw

connection may not be tightened according to the specification.

As a result, the durability of the relevant threaded connections cannot be guaranteed.

- 1 Fastening screws for front left and/or right spring strut (replace)
- Bearing bracket for front left and/or right spring strut (replace)
- Fastening screws for rear left and/or right spring strut (replace)

Action required: Replace the affected fastening screws and tighten them according to specifications. On vehicles on which the front axle is affected, also replace the bearing brackets.
