Mercedes-Benz

Campaign No. 2021040016, May 2021

SUBJECT: **Model C-Class, CLS-Class, E-Class, G-Class, GLC-Class, GT-Class vehicles
(205, 213, 238, 253, 257, 290, and 463 platform)
Model Year 2021
Replace Seat Position Switches**

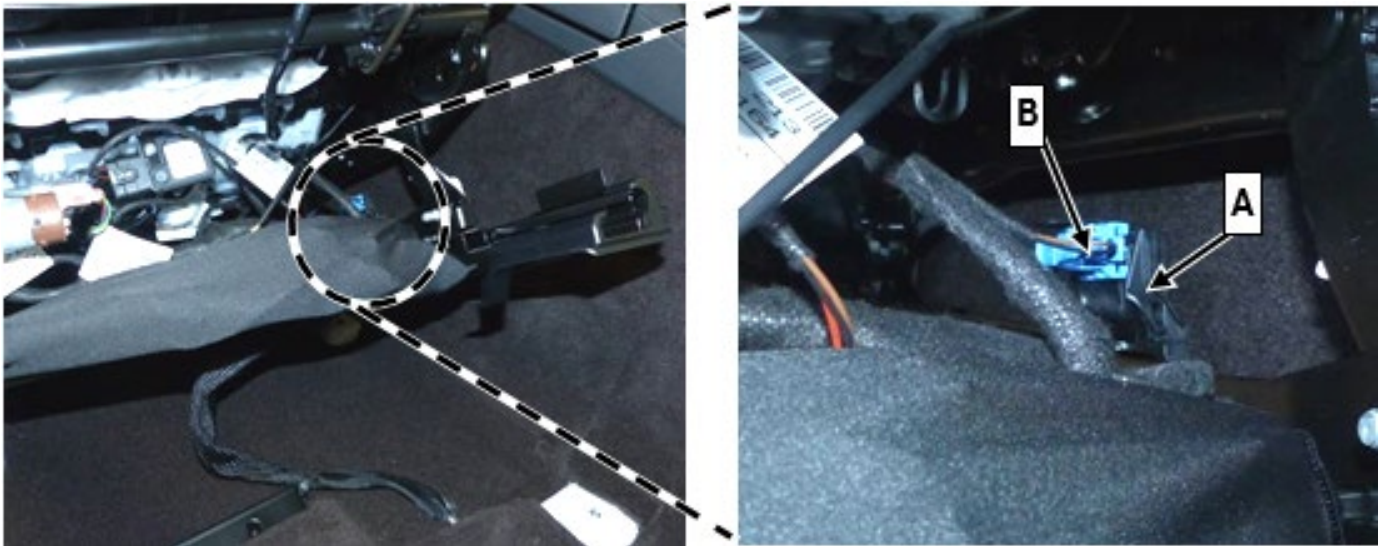
Figure 1 (shown on right front seat)

5. Disconnect electrical connector (**B, Figure 1**) at Hall sensor (**A, Figure 1**).

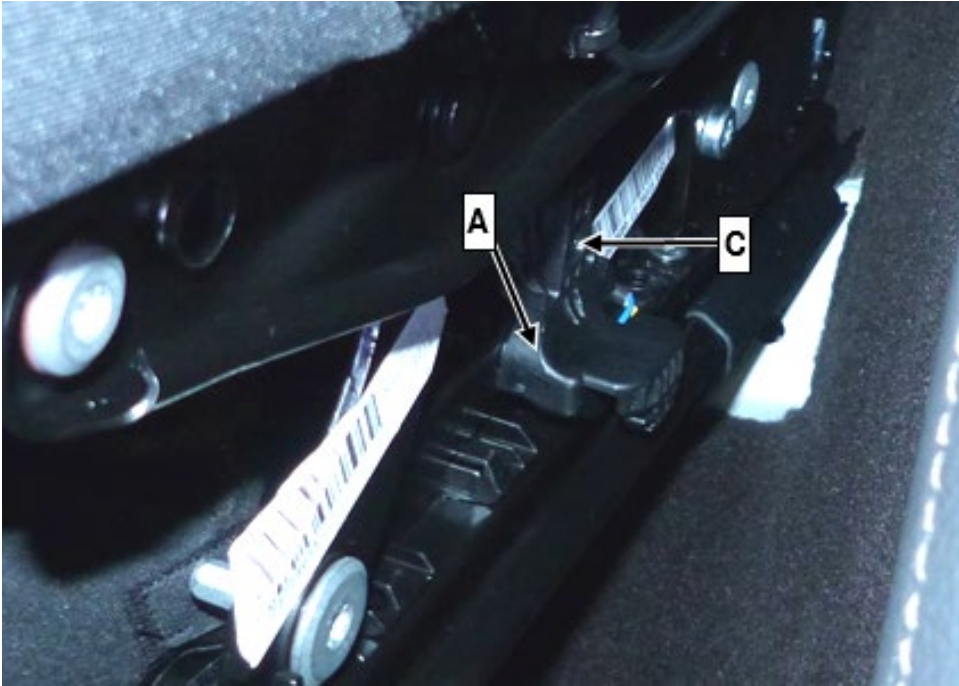
Figure 1 (shown on right front seat)

6. Remove screw (C, Figure 2) at Hall sensor (A, Figure 2).

Hall sensor screw to seat adjustment unit: **3.5 Nm**.
7. Unclip Hall sensor (A, Figure 2) at seat adjustment unit.

8. Assemble in reverse order.
