Mercedes-Benz

Campaign No. 2021050009, June 2021

SUBJECT: **Model GLB-Class vehicles (247 platform)**
Model year 2020-2021

Check Tailgate Side Spoilers

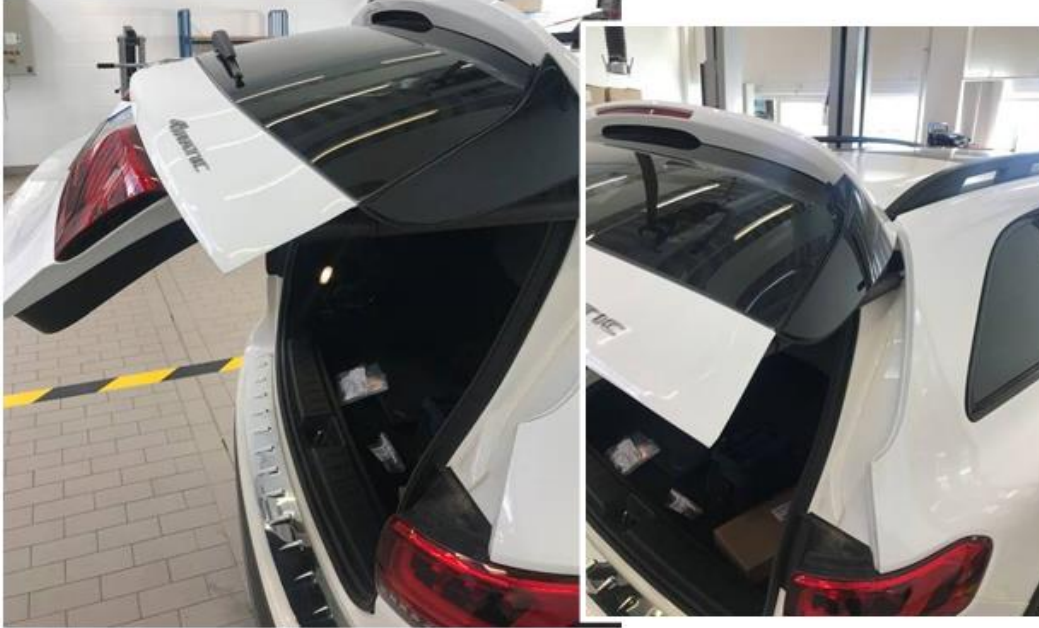
**Figure 1**

i Tailgate **must** be open for the test (**Figure 1**).

1. Open tailgate so that side spoilers are at working height.

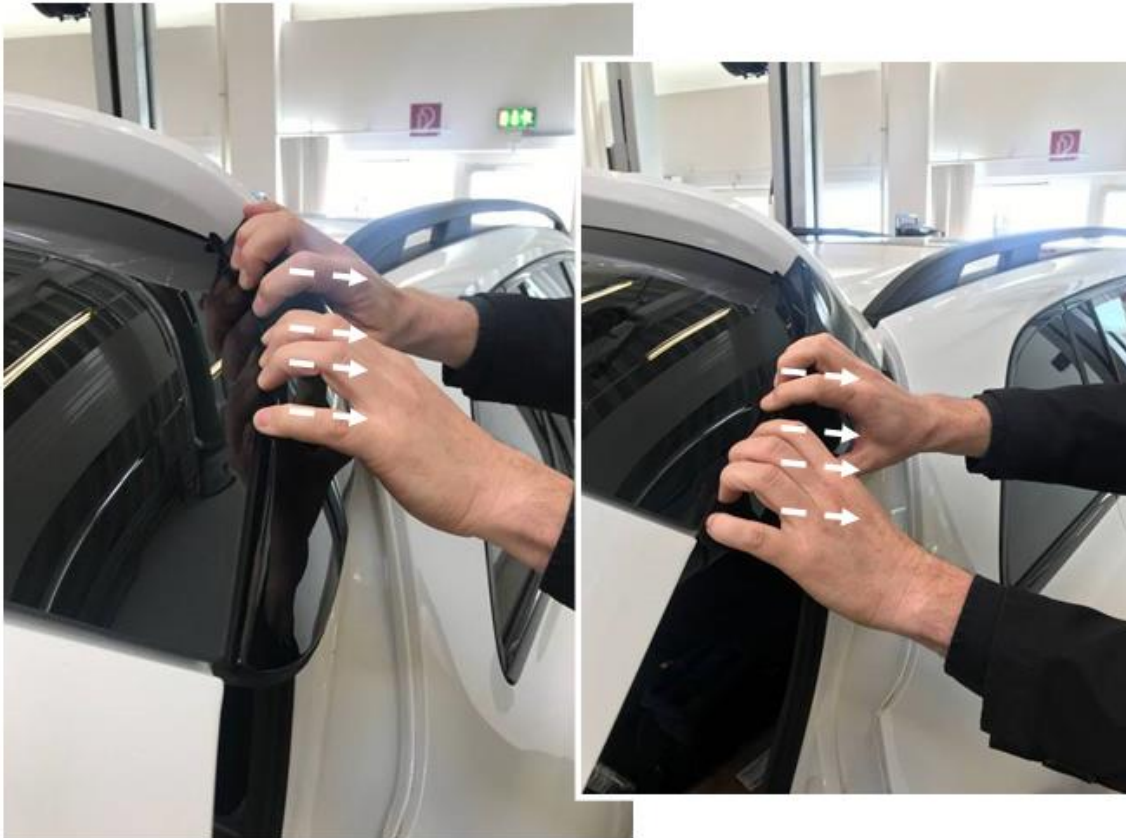
Figure 3

3. Using both hands, pull outward ***slightly*** in upper and lower areas (**Figure 3**).

i The side spoiler must not detach from the tailgate.

- a. Outer shell detaches from basic carrier **or** brackets for clips on side spoiler are broken out: Carry out **work procedure A**.
- b. Side spoiler detaches from tailgate too easily: Carry out **work procedure B**.
- c. Check on side spoilers revealed no problems: **End measure**.

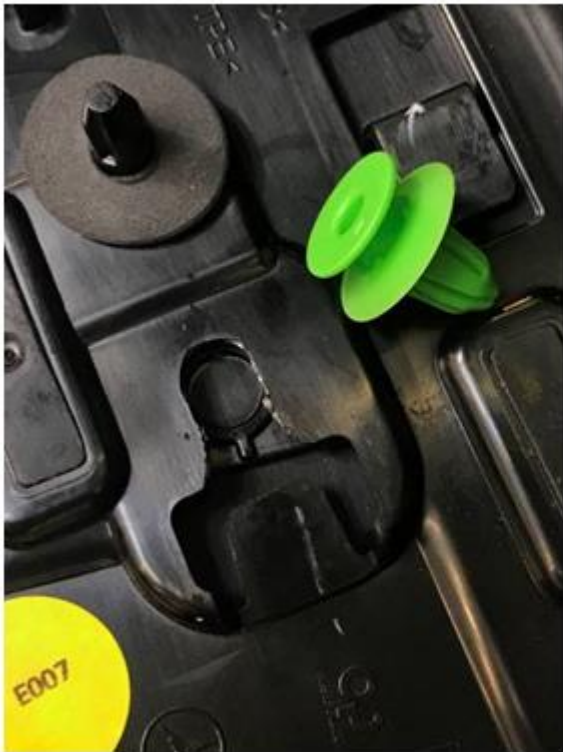
Figure 6, A 001 991 74 98 (green clip)

i For side spoiler in vehicles up to production date **30.Nov.2019 (Figure 6)**, 2 green mounting clips with replacement part no. **A 001 991 74 98** are needed for the two upper fastening points and one gray mounting clip with replacement part no. **A 000 991 31 00 (Figure 7)** is needed for the lower fastening point.

i For the side spoiler in vehicles from productions date **01.Dec.2019 (Figure 5)**, 3 green mounting clips with replacement part no. **A 001 991 74 98** are needed for the upper and lower fastening points (**Figure 6**).

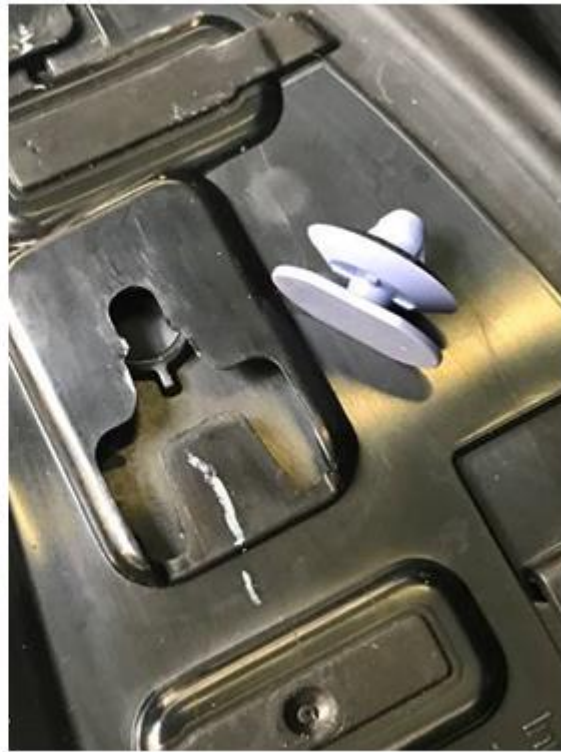
Figure 7, A 000 991 31 00 (gray clip)
