Recall Number:	21V236 — US	2021-201 — Canada
Product:	Turning Point Pin Box	
Date:	04.16.21	Labor Rate: 0.3 Hours Inspection/0.8 Hours Replacement

Purpose

Incorrect Turning Point pin boxes may have been installed on some 5th Wheels, with 10K pin boxes installed instead of 16K pin boxes. A visual inspection is necessary to determine if the incorrect pin box has been installed. If a 10K pin box has been installed, then it must be removed and replaced with a 16K pin box (PN 657275). The inspection and replacement procedures are described in this document.

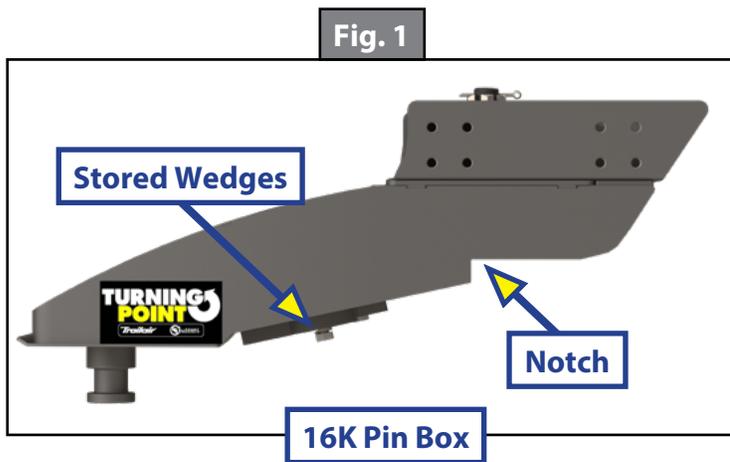
1. Visually examine the bottom side of the pin box profile.
 - A. If there is a notch (Fig. 1) toward the end of the pin box after the stored wedges, it is a 16K pin box. Replacement is not necessary.
 - B. If there is no notch (Fig. 2) where the bottom edge of the pin box extends in a straight line past the stored wedges, it is a 10K pin box and needs to be replaced.

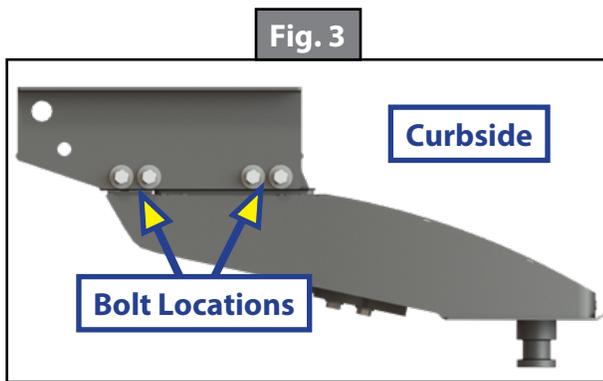
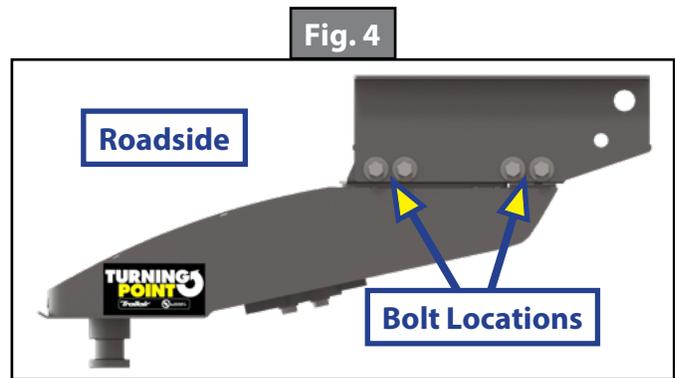
1. Level the 5th Wheel front to back.
2. Make a note of the bolt locations of the factory pin box. The replacement pin box system will be remounted in the same hole settings (Figs. 3 and 4).

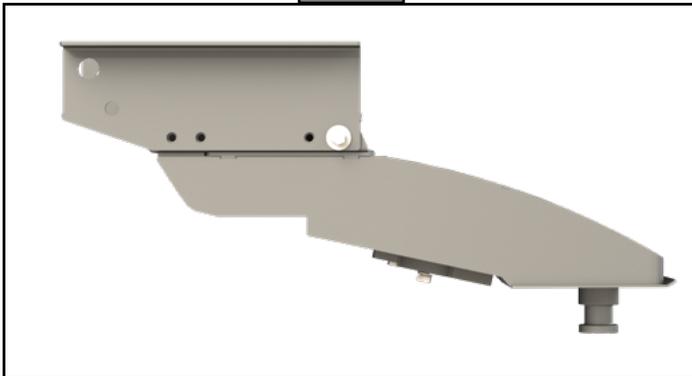
Fig. 5

1. Hoist the new pin box into place.
2. Use a second person to line up the pin box to the mounting plate holes.
3. Using a drift/center pin (or screwdriver), center the holes and install one bolt on the curbside of the trailer at the front of the pin box in one of the same holes used to fasten the factory pin box (Fig. 5).
4. Install at least one bolt on the roadside of the trailer at the rear of the mounting plate (Fig. 6).
5. Reinstall all the bolts, washers and nuts that held the factory pin box in place.

6. Torque the 5/8" bolts to 160 ft-lbs.
