Service Bulletin

American Honda Motor Co., Inc.

SAFETY RECALL

2021 CBR1000RR-R (SP) - REAR CUSHION CONNECTING PLATES

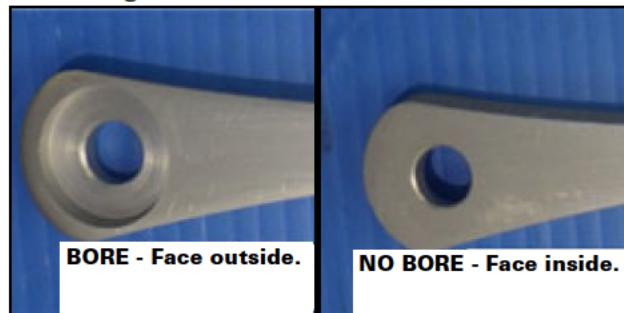
1. Visually check that the bores of the left and right rear cushion connecting plates are facing outside.

- If the motorcycle has the plates installed correctly, no repair is needed. Immediately file warranty template claim KL9A for INSPECTION ONLY.
- If the motorcycle does not have a plate installed correctly, a repair is needed. Contact TechLine for repair determination and parts information. **DO NOT** file a warranty claim at this time.

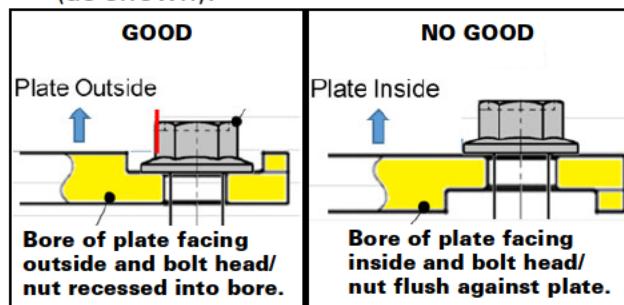
The cushion connecting plate bolt head and nut should both be recessed into the bores of their plates if installed correctly (as shown).
