GROUP	MODEL
Safety Recall Campaign	2020-2021MY Soul (SK3) and 2021MY Seltos (SP2) w/2.0L Nu MPI engine
NUMBER	DATE
SC209	June 2021

ENGINE VIBRATION INSPECTION AND REPLACEMENT (SC209)

This bulletin provides information to perform an engine vibration inspection and, if necessary, replace the engine long block on some 2020-2021MY Soul (SK3) produced from November 24, 2018 through October 24, 2020 and some 2021MY Seltos (SP2) produced from November 20, 2019 through October 15, 2020 vehicles equipped with 2.0L Nu MPI (Atkinson) Engine. The piston oil rings in the affected vehicles may have been improperly heat-treated during production, resulting in excessive oil ring hardness. Excessive oil ring hardness can lead to chipping of the piston oil ring's outer periphery and scuffing of the engine cylinder bore. A scuffed cylinder bore can lead to increased oil consumption which will eventually result in abnormal noise from the engine and/or illumination of the oil pressure warning lamp. If the vehicle is continually operated in this condition, connecting rod bearing seizure can occur. A seized connecting rod bearing can result in engine damage, thereby increasing the risk of an engine sta

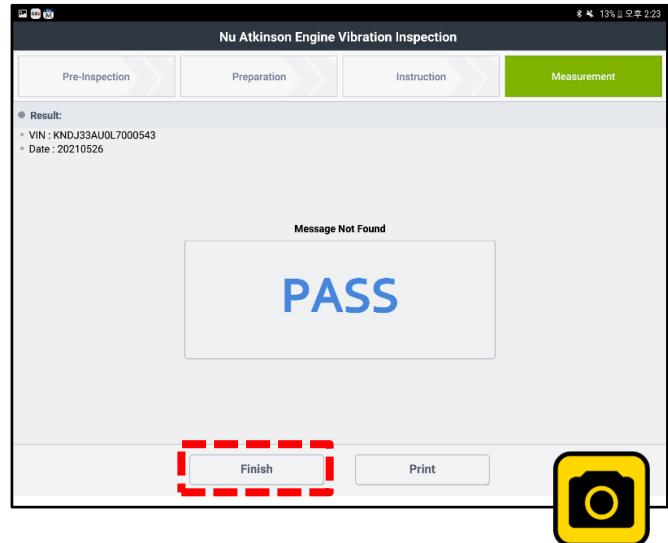
PASS: If the measured engine vibration test has a normal condition, capture the screen image/screenshot for record keeping and attach to the warranty claim using Attachment Type - 'XX': Other. Select 'Finish'.

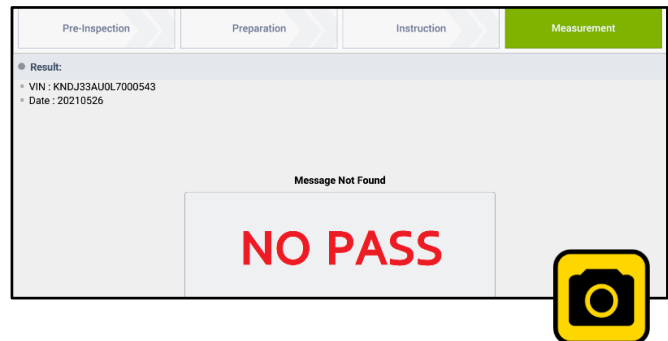
10b. **NO PASS:** If the measured engine vibration test is abnormal capture the screen image/screenshot for record keeping and attach to the warranty claim using Attachment Type - 'XX': Other. → **Open a Techline case online for further instructions.**

Select 'Finish' and replace the engine long block by referring to the "Engine Mechanical System → Engine And Transaxle Assembly → Repair procedures" chapter in the applicable Shop Manual on KGIS. Refer to page 7 information.

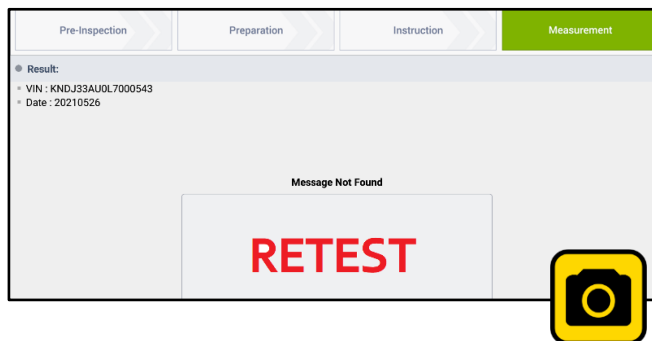
RETEST: If there's an **error** on the measured engine vibration test, check the jack input (microphone) and knock sensor connection and perform measuring test again.

NOTE: If the results keep displaying 'RETEST' (more than 2 times), open a Techline case online for further instructions.
