GROUP	MODEL
Safety Recall Campaign	2020-2021MY Soul (SK3) and 2021MY Seltos (SP2) w/2.0L Nu MPI engine
NUMBER	DATE
SC209 (Rev 4, 04/06/2022)	June 2021

ENGINE VIBRATION INSPECTION AND REPLACEMENT (SC209)

This bulletin provides information to perform an engine vibration inspection and, if necessary, replace the engine long block on some 2020-2021MY Soul (SK3) produced from November 24, 2018 through October 24, 2020 and some 2021MY Seltos (SP2) produced from November 20, 2019 through October 15, 2020 vehicles equipped with 2.0L Nu MPI (Atkinson) Engine. The piston oil rings in the affected vehicles may have been improperly heat-treated during production, resulting in excessive oil ring hardness. Excessive oil ring hardness can lead to chipping of the piston oil ring's outer periphery and scuffing of the engine cylinder bore. A scuffed cylinder bore can lead to increased oil consumption which will eventually result in abnormal noise from the engine and/or illumination of the oil pressure warning lamp. If the vehicle is continually operated in this condition, connecting rod bearing seizure can occur. A seized connecting rod bearing can result in engine damage, thereby increasing the r

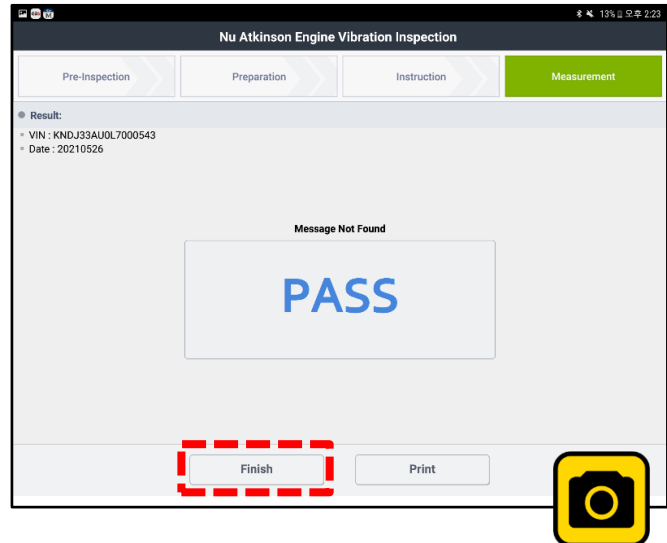
10a. **PASS:** If the measured engine vibration test has a normal condition, capture the screen image/screenshot for record keeping and attach to the warranty claim using Attachment Type - 'XX': Other. Select 'Finish'.

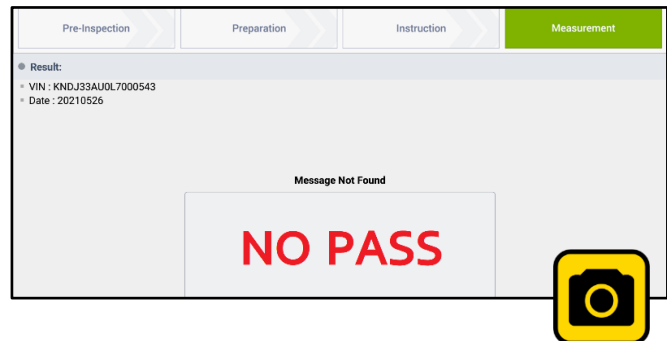
10b. **NO PASS:** If the measured engine vibration test is abnormal capture the screen image/screenshot for record keeping and attach to the warranty claim using Attachment Type - 'XX': Other. → **Open a Techline case online for further instructions.**

Select 'Finish' and replace the engine long block by referring to the "Engine Mechanical System → Engine And Transaxle Assembly → Repair procedures" chapter in the applicable Shop Manual on KGIS. Refer to page 7 information.

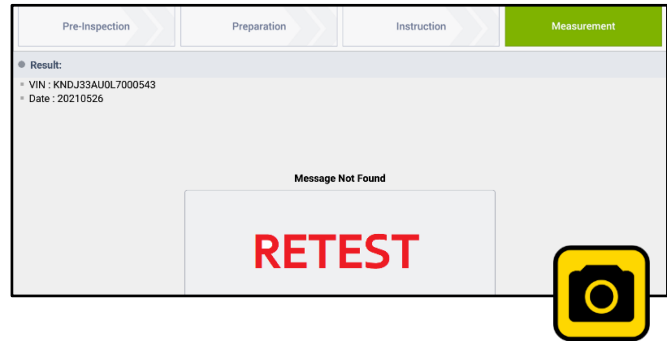
- 10c. **RETEST:** If there's an **error** on the measured engine vibration test, check the jack input (microphone) and knock sensor connection and perform measuring test again.

NOTE: If the results keep displaying 'RETEST' (more than 2 times), open a Techline case online for further instructions.
