PRODUCT CAMPAIGN BULLETIN

APPLICABILITY: 2017-2019 MY Impreza
2018-2019 MY Crosstrek

NUMBER: WRE-21R

SUBJECT: Ignition Coil Replacement

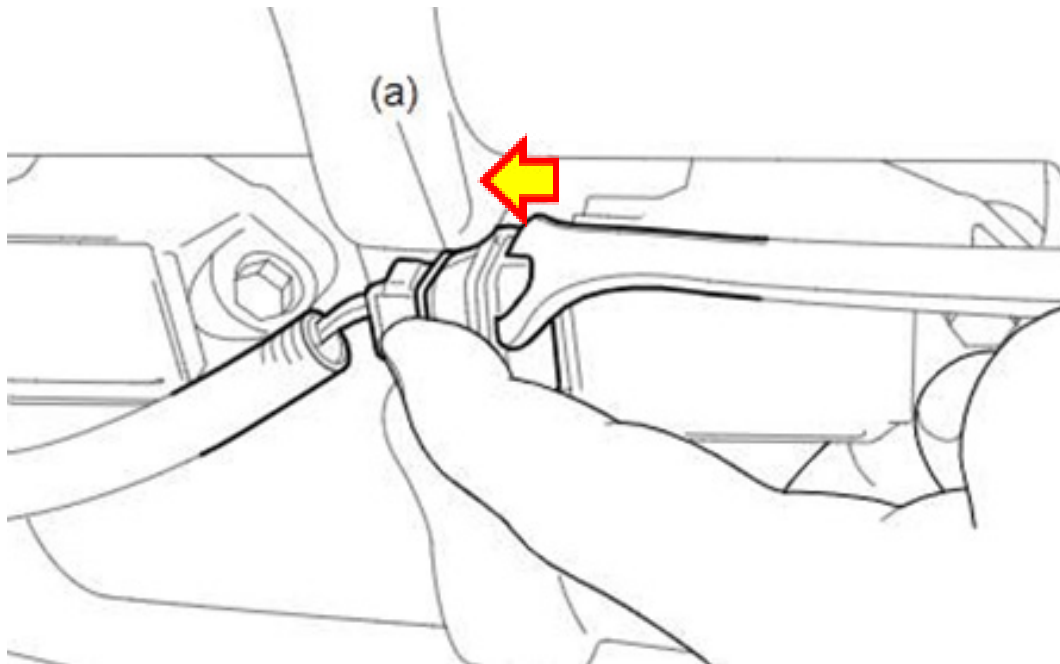
TIP: When disconnecting the harness connectors from the ignition coils, squeeze the wire retaining clip (a) and push the connector off using a trim clip tool as shown in the illustration below. **DO NOT** remove the wire retaining clip from the harness connector.

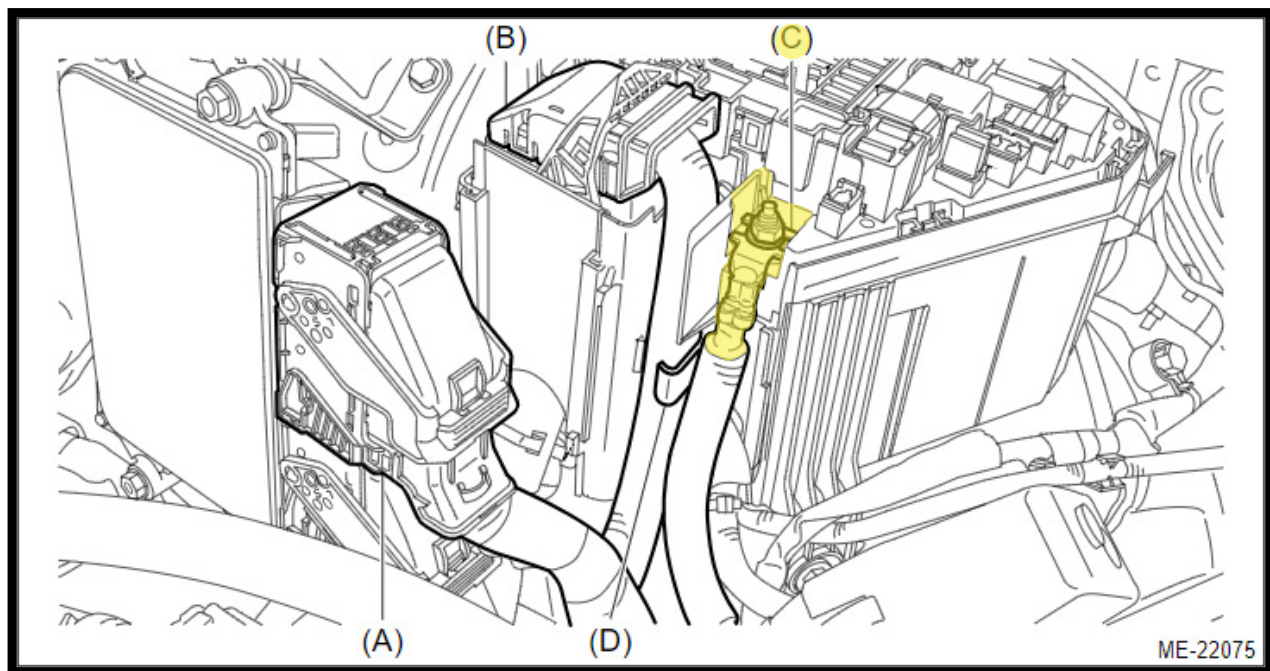
It is **CRITICAL** to confirm a secure connection of terminal (C) to the main fuse box. The terminal **MUST** be torqued to **7.5N·m (0.8kgf-m, 5.5ft-lb)**.
