**PRODUCT CAMPAIGN BULLETIN**

**APPLICABILITY:** 2017-2019 MY Impreza  
2018-2019 MY Crosstrek

**NUMBER:** WRE-21R

**SUBJECT:** Ignition Coil Replacement

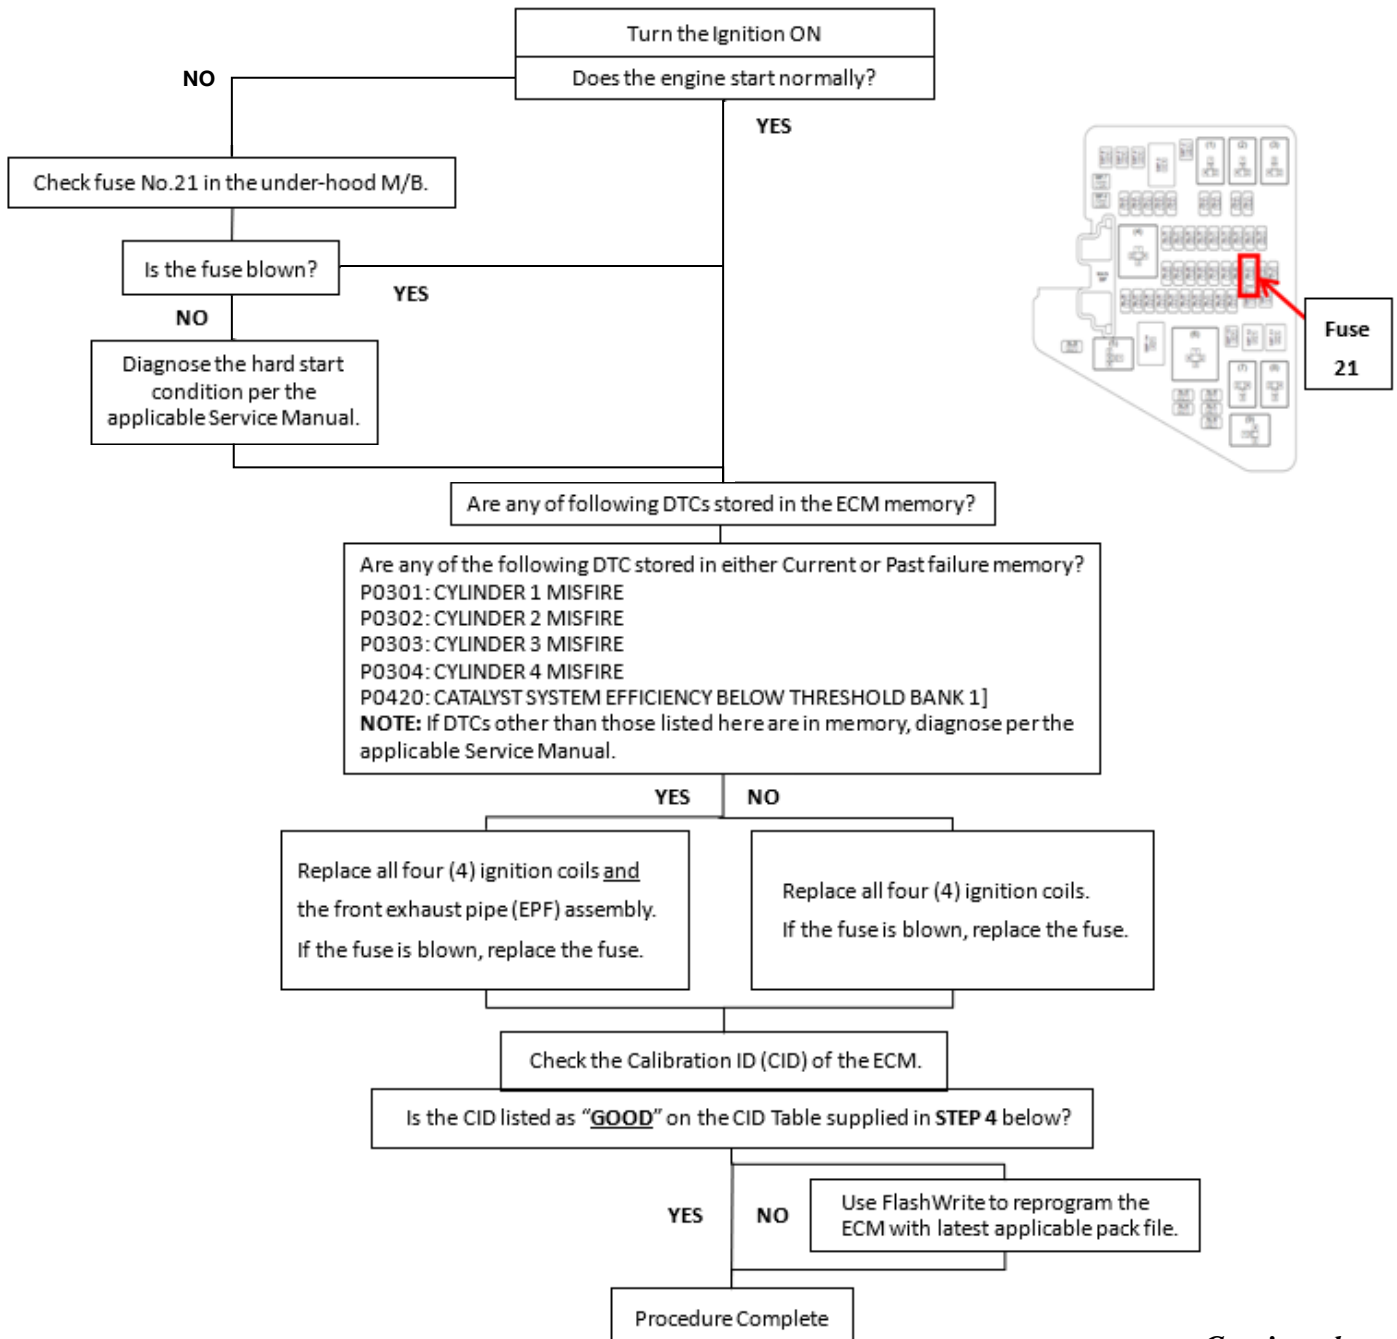
The following Flow Chart is provided as an overview of the procedures required to perform this Recall. A detailed Service Procedure is also supplied below.
