PRODUCT CAMPAIGN BULLETIN

APPLICABILITY: 2017-2019 MY Impreza
2018-2019 MY Crosstrek

NUMBER: WRE-21

SUBJECT: Ignition Coil Replacement

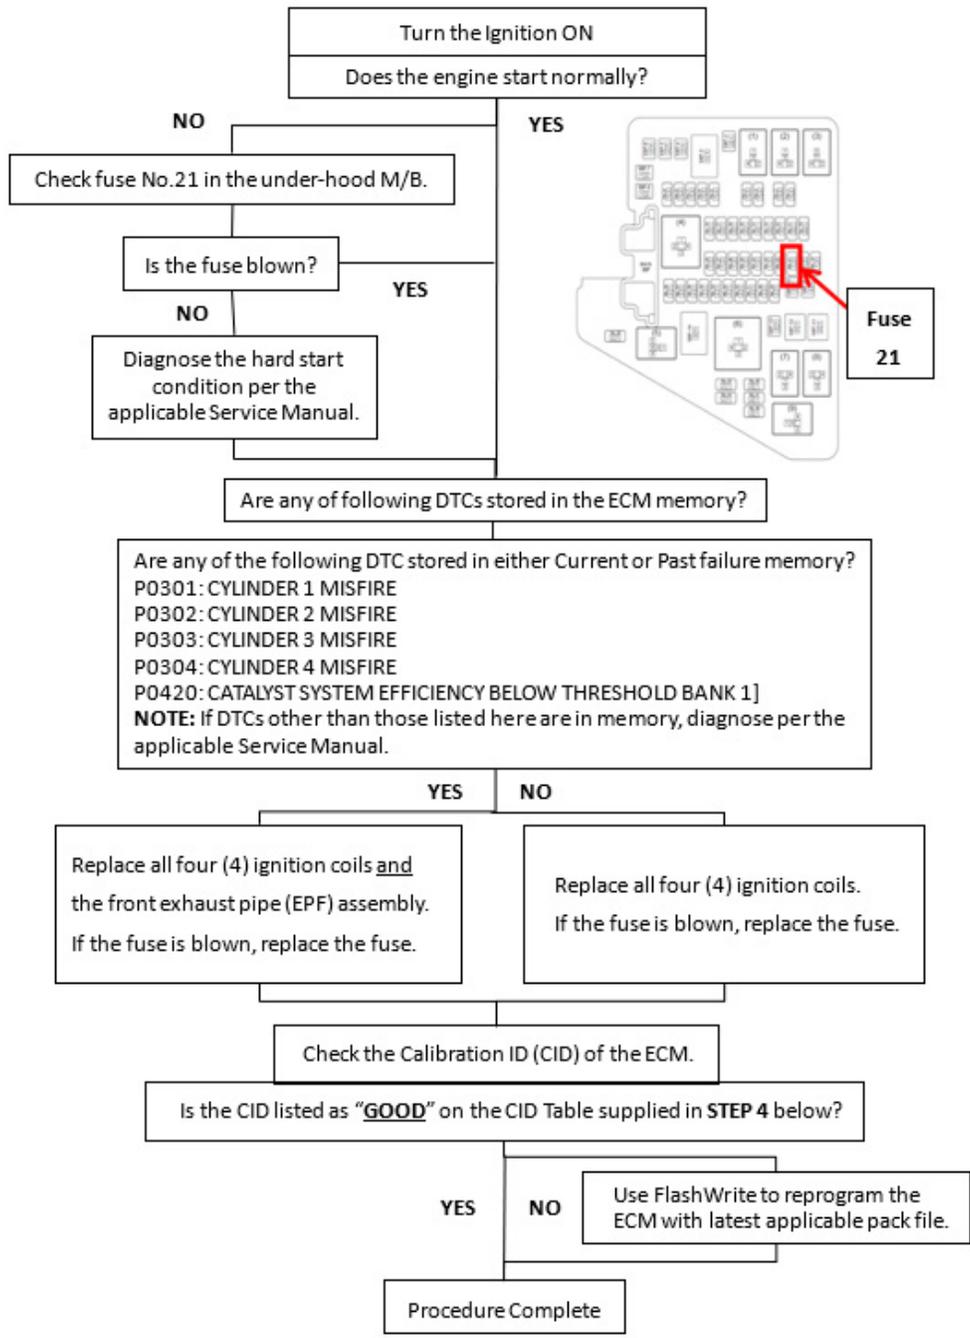
The following Flow Chart is provided as an overview of the procedures required to perform this Recall. A detailed Service Procedure is also supplied below.
