HYUNDAI
Technical Service Bulletin

GROUP RECALL	NUMBER 21-01-052H
DATE JUNE, 2021	MODEL(S) SANTA FE SPORT (AN)

SUBJECT: ABS MODULE INSPECTION AND MULTI-FUSE INSTALLATION
 (RECALL CAMPAIGN 205)

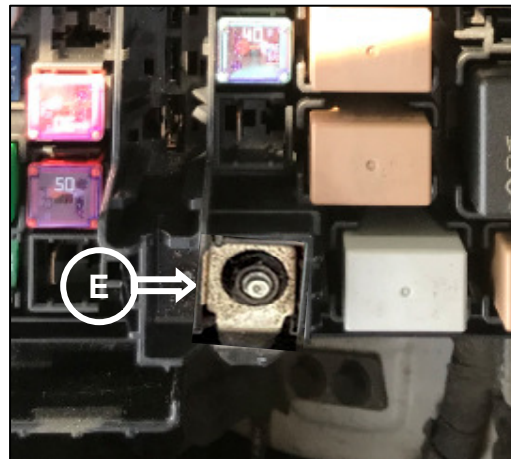
4. Place the junction box cable over the junction box stud (E), reinstall the nut and reconnect the battery negative (-) terminal.

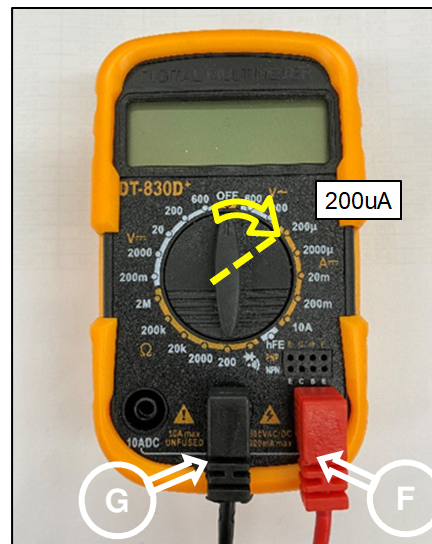
5. Connect the red multimeter lead to VΩmA (F) and the black lead to COM (G). Turn the dial to 200μA.

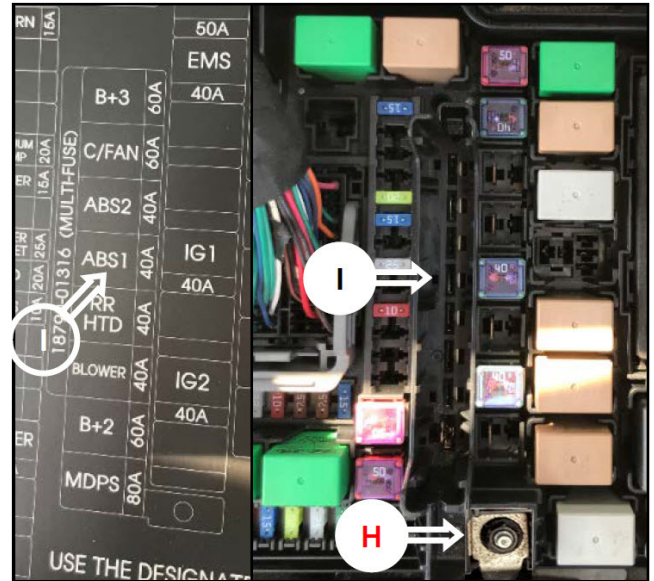
6. Place the **red** lead probe of the multimeter against the side of the junction box stud (H).
Place the **black** lead probe on the ABS1 terminals (I) in the junction box.

- Measurement must be taken for at least 15 seconds to obtain a stable reading.
- Use care not to damage the ABS1 terminals in the junction box with the multimeter black lead probe.

- If no current is detected or if the measured value is less than 1.0µA, ensure the junction box cable is connected to the junction box stud and the 12V Battery (-) terminal has been reconnected.

8. ➤ If the measured current value is **70 μ A or greater, replace the Hydraulic Unit Assembly (HECU), then continue to step 9 to replace the multi-fuse and upper cover (Service Kit).**
- If the measured current value is **less than 70 μ A**, HECU replacement is not needed at this time. **Continue to step 9 to replace the multi-fuse and upper cover (Service Kit).**
