Dealer Service Instructions for:

Safety Recall Y18 / NHTSA 21V-310 Transmission Oil Cooler Hose

2021 (KL) Jeep® Cherokee

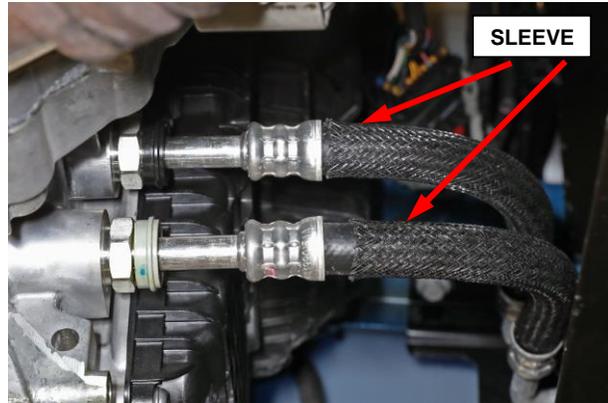
Figure 2 – Oil Cooler Line Sleeve

4. Slide protective sleeve aside on both hoses until timestamp is visible (Figure 2).

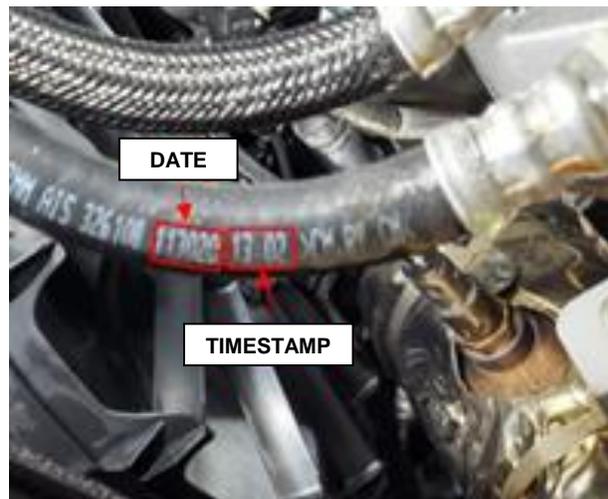
Figure 3 – Inspect Date Stamp

5. Inspect both hoses. If the date is 113020 and timestamp between 12:59 and 13:21 on either hose, proceed to removal procedure. If not, reassemble the vehicle and return it to the customer (Figure 3).

NOTE: The date and time stamps in Figure 3 are shown on the bottom of the hose. But the stampings may be on the top or sides of the hose. Use a mirror if necessary to inspect the codes.
