**RECALL: NHTSA 21V356**

**SUBJECT:** Internal Regulator Causing Overvoltage

**APPLIES TO:** Roadtrek: Zion, Zion SRT and Play models

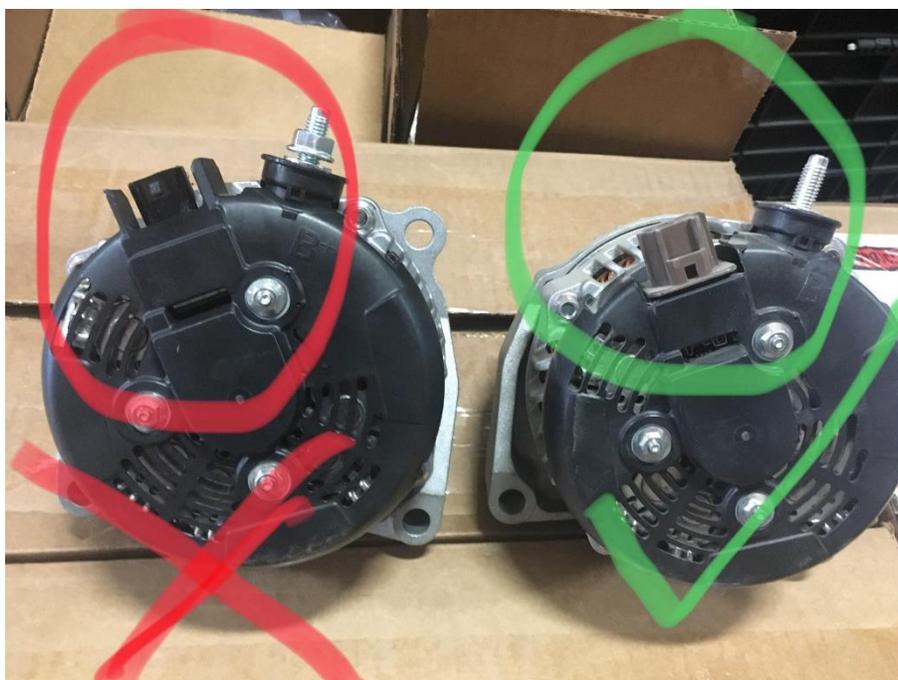
**CONDITION:** Faulty internal regulator that may potentially enter a stage of overvoltage exceeding 16 volts that could damage the RV mounted auxiliary AGM black capped batteries.

**CORRECTION:** Remove the GU splash guard from the undermounted additional alternator. Inspect the additional GU alternator to determine the colour of the Internal regulator cover.

If the cover is found to be **brown**, the regulator is the good one. No further action is required. Replace the splash guard and fill-out the enclosed form accordingly and return it to: [dealersupport@roadtrekinc.com](mailto:dealersupport@roadtrekinc.com)

If the additional undermounted GU is found to have an internal regulator cover that is **black**, send a picture of the defective alternator including the serial number to [dealersupport@roadtrekinc.com](mailto:dealersupport@roadtrekinc.com). Roadtrek will send you a replacement alternator. Once that replacement is received, replace the defective undermounted GU alternator according to the instructions below. Once the replacement is completed, fill out the enclosed corrective action form and send it to us **along with the recalled GU alternator**.
