RECALL 21V374. 2021-306 REMEDY INSTRUCTIONS

Make(s): COLUMBUS
Model(s): MANY, SEE BELOW
Model Year(s): 2021

Concern:
The breakaway switch may not be correctly wired to constant hot. This condition may lead to the failure of the brake-away switch to activate in an emergency.

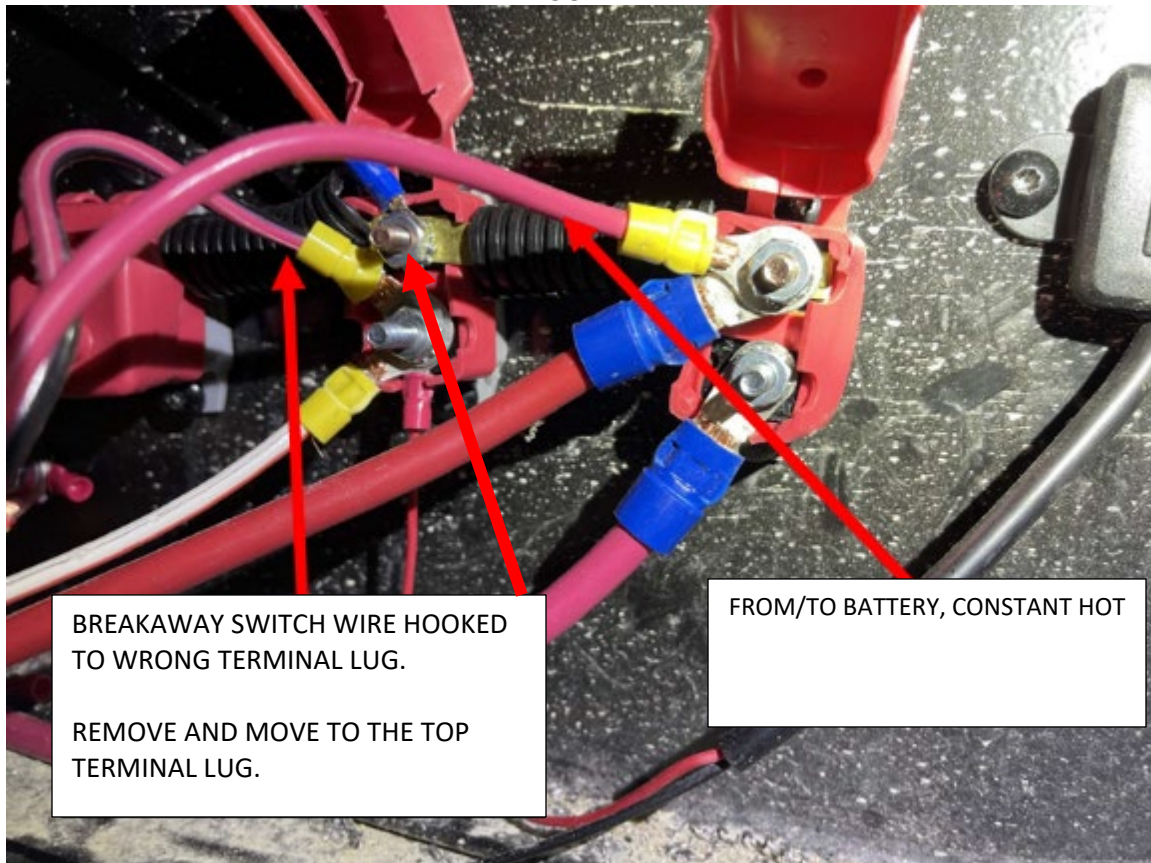
FIGURE 1

STEP 1: LOCATE BATTERY CONSTANT POWER AUTO-RESET BREAKERS (FIG. 1);

STEP 2: LOCATE THE BREAKAWAY SWITCH WIRE HOOKED TO THE NON-CONSTANT POWER POST (FIG. 1);

STEP 3: REMOVE THE BREAKAWAY SWITCH WIRE FROM NON-CONSTANT POWER POST;

STEP 4: INSTALL BREAKAWAY SWITCH WIRE TO POST THAT IS CONSTANT POWER BY BATTERY (FIG. 1);
