06.2021
 SC0425
 01
 1(4)

Proprietary Hubcap Insufficient Retention AN, GR, and PI

RECALL INFORMATION

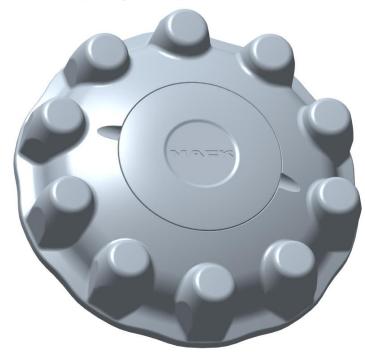
Mack has determined that some proprietary hubcap wheel covers, lack the spring retention force required to retain the hubcap to the wheel. These wheel covers could become separated from the vehicle while in motion, If the hubcap cover comes off, it can result in a hazard to other road users and potentially result in an injury.

Mack Proprietary Hubcap wheel cover shown below

- 1. Secure truck for service.
- 2. Remove all proprietary hubcap wheel covers.
- 3. Destroy the removed proprietary hubcap wheel covers so they cannot be reused.
- 4. Recycle the destroyed proprietary hubcap wheel covers in accordance with state and local regulations.
- 5. Release the truck to service.
