WARRANTY BULLETIN SAFETY CAMPAIGN

Campaign no.: 2021-0006

Subject: **Move I 1500 Extended Trailer Spindle Weld Failure - Possible Wheel Loss**

No. **2021-4**

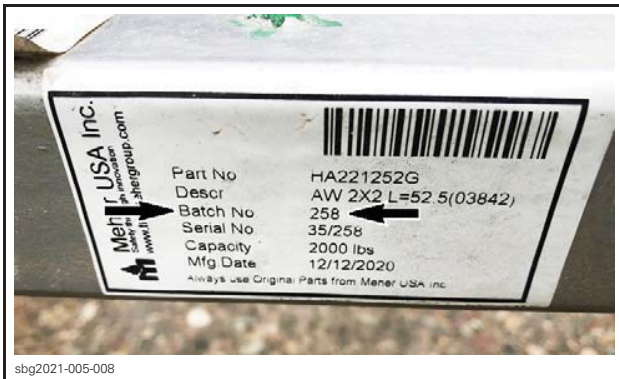
TYPICAL

Inspect axle tag, located in the middle of the axle and take note the Batch number.

NOTE: The axle tag will be either a white sticker (as shown) or a metal plate.

AFFECTED BATCH NUMBER
256
258
260

If the trailer is from one of the affected batches, proceed to *AXLE REPLACEMENT*. If not, no further action is required.

In case the batch number is not visible or missing, proceed to *AXLE REPLACEMENT*.
