Thor Motor Coach Recall Repair Instructions

Recall #	21V-441 2021-361		
Description/Title:	25.6 Axis/Vegas Heat Shield		
Affected Product Line(s):	Certain Model Year 2018-2022 25.6 Axis & Vegas motorhomes		
Service Campaign # :	RC000228	Released Date:	7/19/2021
Repair Code:	TMCRC80499V	Document Date:	7/19/2021
Time Allowed:	1.0	Document Revision:	A

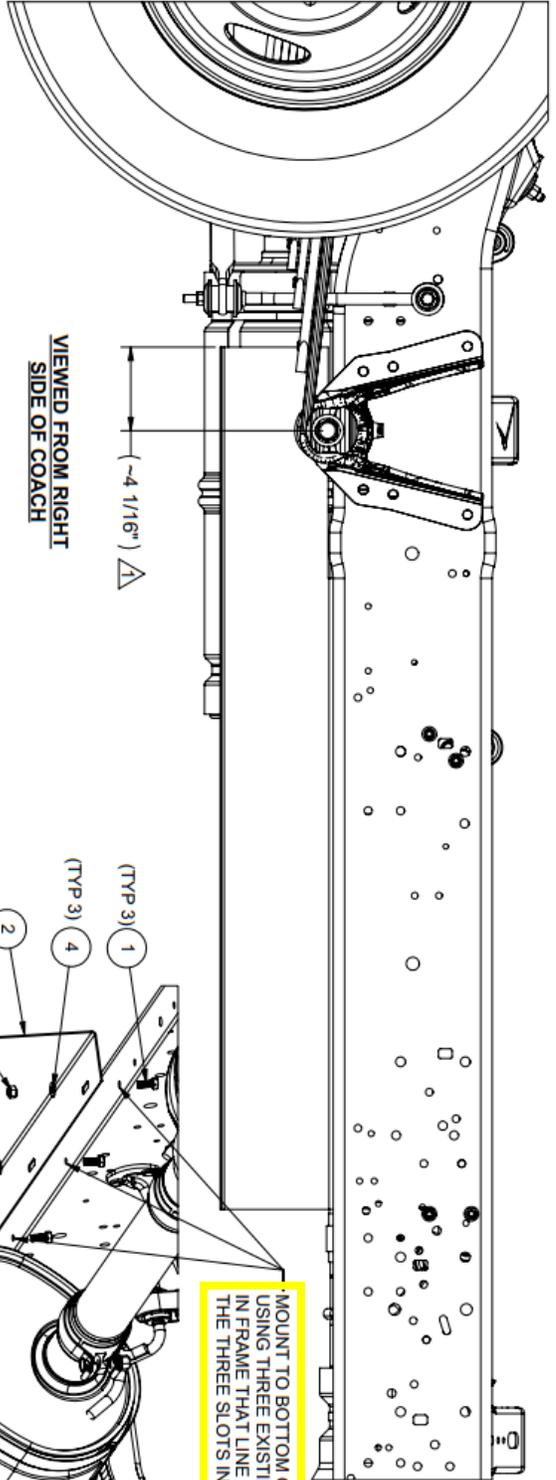
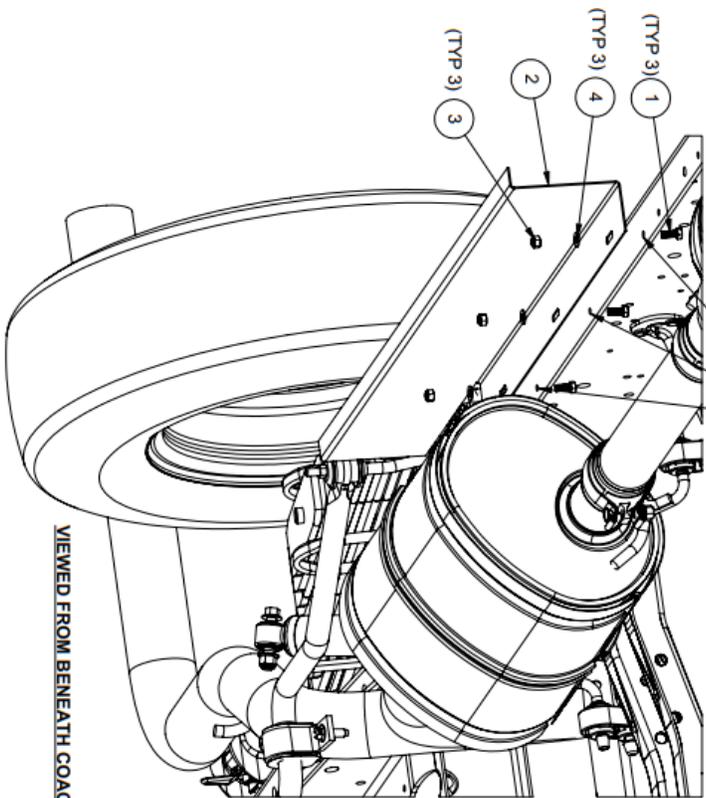
THOR MOTOR COACH	
DESCRIPTION	INSTALLATION, HEAT SHIELD
DATE	03/28/2021
DRAWN BY	D. FRANKS
CHECKED BY	
DATE	
MODEL	XSVS 25.6
DRAWING NUMBER	TIP0270
REVISION	1

It has been discovered that on certain model year 2018-2022 25.6 Axis and Vegas Motorhomes, a heat shield is missing between the LP tank and chassis muffler. A heat shield was not properly installed in between the LP tank and chassis muffler during production, which is required if measurement is less than 18". Current measurement is 11.8", which does not follow guidelines of RVIA 5.2.5.1. There is a potential risk for a fire and/or property damage, which could result in serious injury or death.

1. Mount Heat Shield (TFM7403) to bottom of chassis frame using existing holes in frame that line up with the three slots in TFM7403 using supplied fasteners. Reference TIP0270 (found on next page) for assembly print.

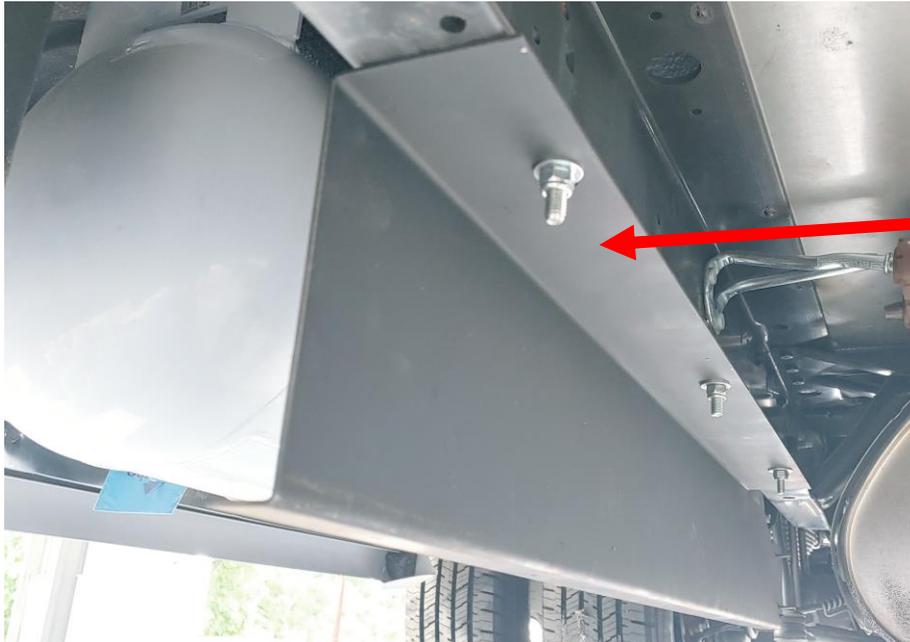
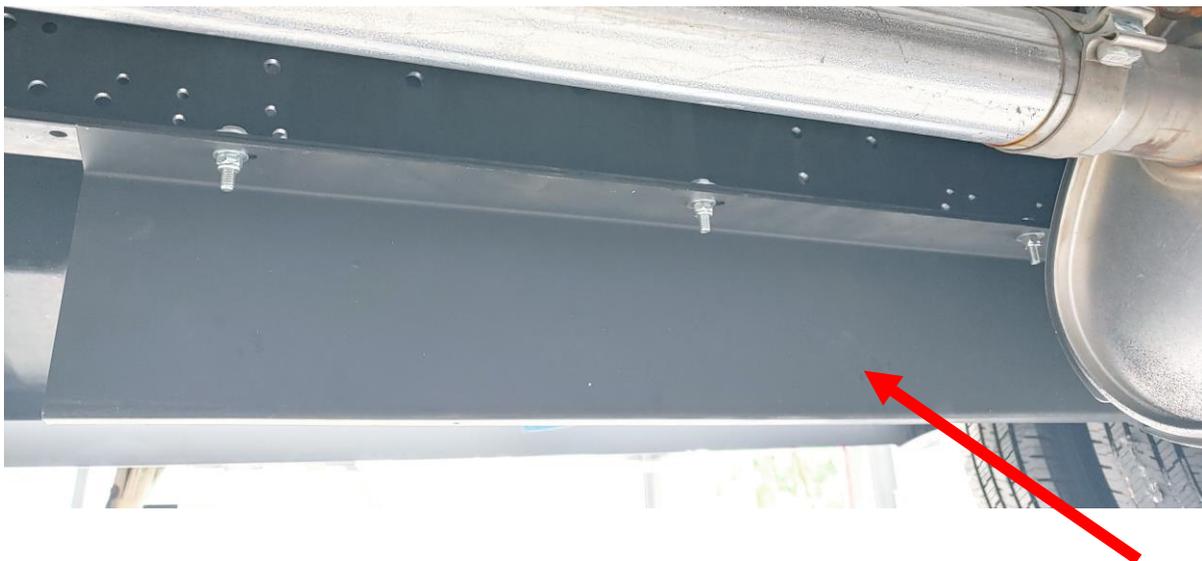
Below are photos of the heat shield once it has been properly mounted to the bottom of the chassis frame.
