# VOLUNTARY RECALL CAMPAIGN

Classification:	Reference:	Date:	
ST21-003A	NTB21-052A	August 14, 2023

# VOLUNTARY SAFETY RECALL CAMPAIGN 2020-2021 SENTRA; INNER TIE ROD

CAMPAIGN ID #: PM985

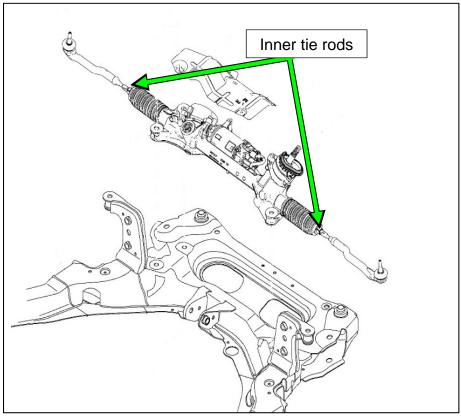
Figure 1

- 1. Place the vehicle on a lift and raise to a suitable height.
- 2. Locate the LH and RH inner sockets (inner tie rods).
