RECALL CAMPAIGN BULLETIN

Classification:	Reference:	Date:
ST21-003	NTB21-052	June 17, 2021

VOLUNTARY SAFETY RECALL CAMPAIGN 2020-2021 SENTRA; INNER TIE ROD

CAMPAIGN ID #: PM985
APPLIED VEHICLES: 2020-2021 Sentra (B18)

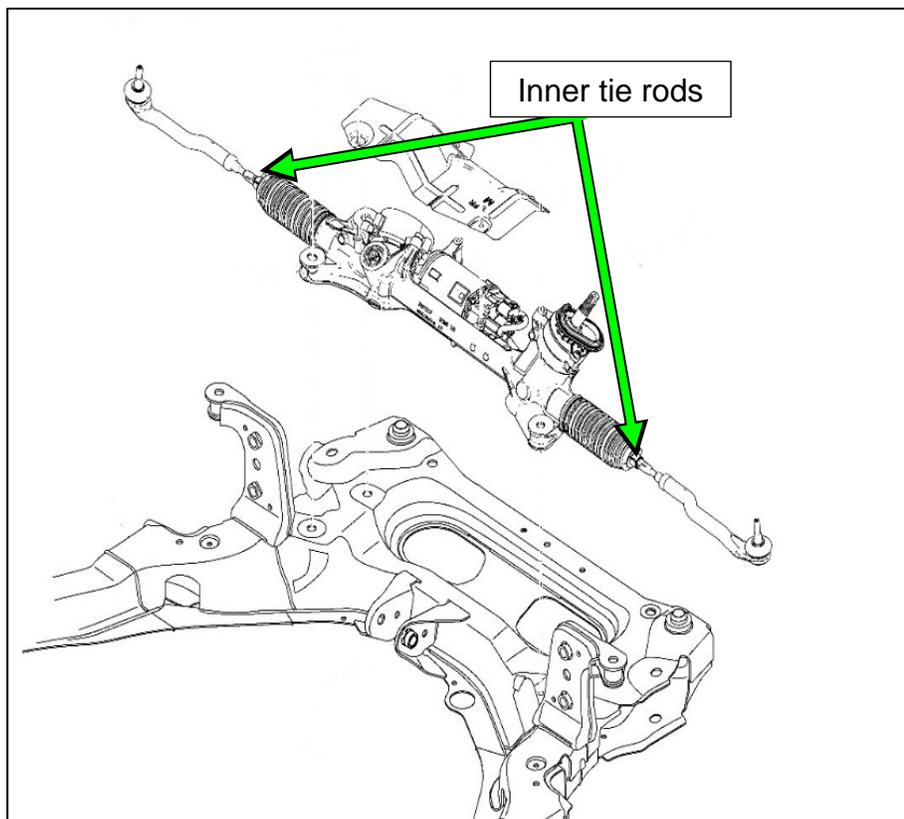
Figure 1

1. Place the vehicle on a lift and raise to a suitable height.
2. Locate the LH and RH inner sockets (inner tie rods).

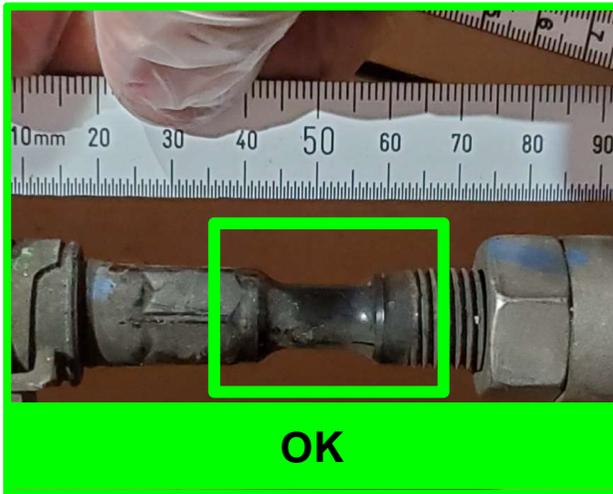
Figure 2

3. Inspect each inner tie rod for a bent condition by placing a straight edge on each inner tie rod (Figure 2 and Figure 3).

- If an inner tie rod is **NG**, proceed to step 4 for inner tie rod replacement.
- If an inner tie rod is **OK**, inspection is complete and no further action is required.
 - Lower the vehicle and return to the customer.
 - Review the **CLAIMS INFORMATION** on page 4 and submit a warranty claim.

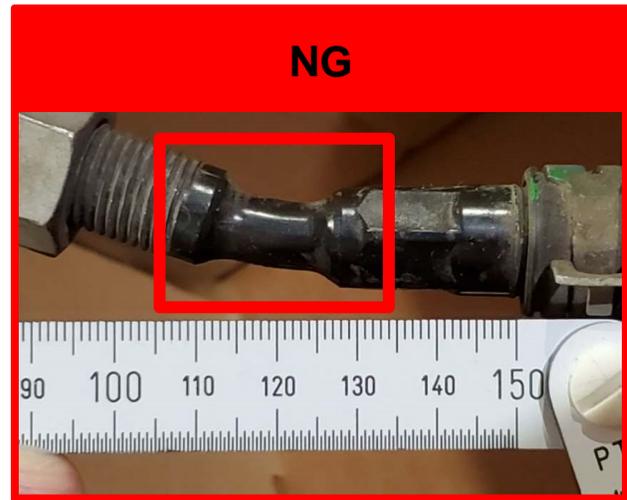
NOTE: The inner tie rod in Figure 3 has an exaggerated bend. Inner tie rod(s) that are found to be bent may not be as extreme. Inner tie rod(s) found with any bent condition should be considered **NG**.

4. Replace the **NG** inner tie rod(s).
 - For inner tie rod replacement, refer to the ESM section below.
 - **STEERING > STEERING SYSTEM > REMOVAL AND INSTALLATION > STEERING GEAR AND LINKAGE > Removal and Installation – Inner socket**
5. Perform a 4-wheel alignment.
