L62X-R.02.21

Rear View Camera not available - Kombi update

Model:Huracán 4WD, Huracán 2WD, Huracán Performante,
Huracán EVO**Model year:**

As a result of continuous product monitoring, Automobili Lamborghini S.p.A. has determined that some vehicles were manufactured with a software bug within the infotainment system which when subjected to temperatures below 41 degrees Fahrenheit and after a long sleep may some-times generate a fault that renders the rear view (back-up) camera inoperable until the next power latch.

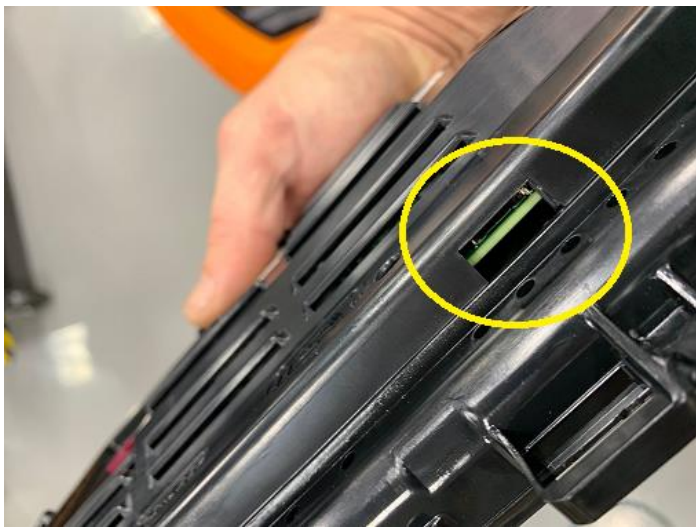
The typical USB flash drive is NOT being used for this update, a Micro SD card must be used to download the software as in the picture below you will see the Micro SD slot on the bottom of the instrument cluster.
