TI No.: 75.00U21166A

Model: S 417 TC, S 407 CC

TITLE: **S 417 TC, S 407 CC - Fitting arrester cables to the engine compartment flap**

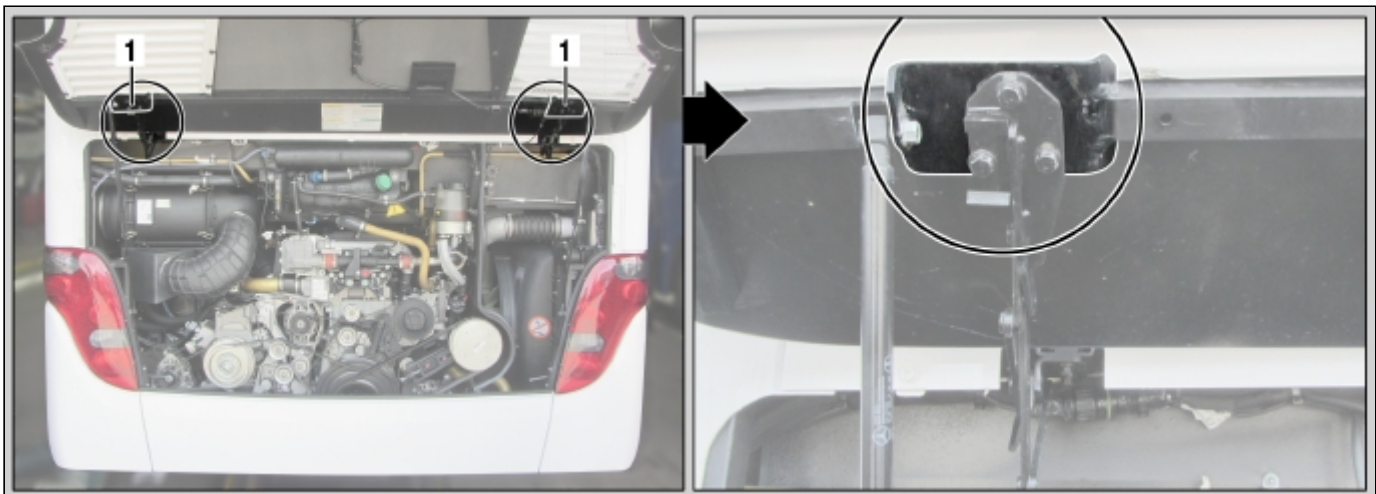
M88.40-A000-74

1. Open the engine compartment flap.
2. Check for cracks at all existing weld seams on left- and right-side bracket **(1)** of the engine compartment flap.

Cracks found at the weld seams.

No cracks found at the weld seams.

- ▶ Replace the engine compartment flap with a new one.
- ▶ Fit arrester cables.

- ▶ Fit arrester cables.
