RECALL CAMPAIGN BULLETIN

| Classification: EL21-003 | Reference: NTB21-056 | Date: June 23, 2021 |

VOLUNTARY RECALL CAMPAIGN 2020-2021 TITAN/TITAN XD FRONT TURN SIGNAL BULB INSPECTION

CAMPAIGN ID #: PC811
APPLIED VEHICLES: 2020-2021 Titan/Titan XD (A61)

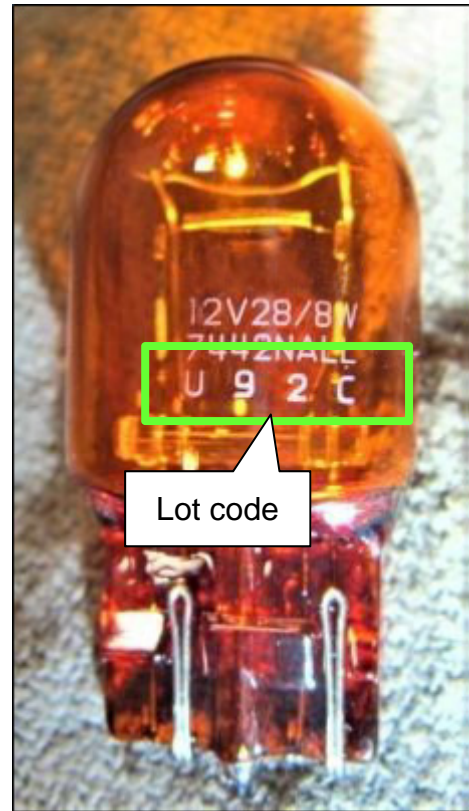
Figure 6

3. Locate the four character alpha numeric “lot code” of the bulb (Figure 6), and then write it on the repair order.

- **YES:** Replace the bulb.
- **NO:** Do NOT replace the bulb.

5. Inspect the lot code on the new replacement bulb before it is installed, and confirm that it is not in **Table 1**.
