RECALL CAMPAIGN BULLETIN

EL21-002
 NTB21-057
 June 23, 2021

VOLUNTARY RECALL CAMPAIGN 2020-2021 VERSA FRONT TURN SIGNAL BULB INSPECTION

CAMPAIGN ID #: PM986

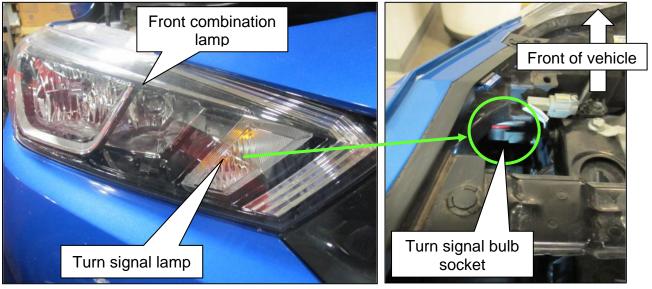
Figure 1 Figure 2

- 1. Open the hood.
- 2. Locate the front driver side combination lamp (Figure 1).

- 3. Remove the driver side turn signal bulb (bulb) from the front combination lamp (Figure 2).
 - Refer to the Electronic Service Manual (ESM): Section DRIVER CONTROLS >
 EXTERIOR LIGHTING SYSTEM > HALOGEN HEADLAMP (or) LED
 HEADLAMP > REMOVAL AND INSTALLATION > FRONT COMBINATION
 LAMP > Bulb Replacement.

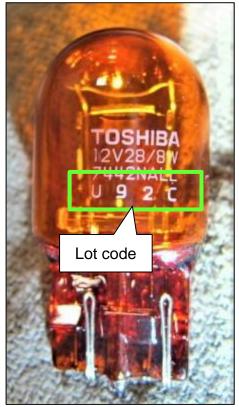
Figure 3

- 4. Locate the four character alpha numeric "lot code" of the bulb (Figure 3), and then write it on the repair order.
 - Use of a light source may help to read the lot code.
- 5. Is the lot code in **Table 1** below?
 - **YES:** Replace the bulb.
 - NO: Do NOT replace the bulb.

X9ZR, X01M, X01N, X9ZQ, X998

- 6. Inspect the lot code on the new replacement bulb before it is installed, and confirm that it is not in **Table 1**.
 - If the new replacement bulb is in Table 1, choose a different bulb and recheck against
 Table 1 until one is found that is not NG.
