RECALL CAMPAIGN BULLETIN

Classification: RS21-005	Reference: NTB21-060	Date: June 29, 2021
-----------------------------	-------------------------	------------------------

VOLUNTARY SAFETY RECALL CAMPAIGN 2021 ROGUE; REAR SEAT TETHER INSPECTION

CAMPAIGN ID #: PC812
APPLIED VEHICLES: 2021 Rogue (T33)

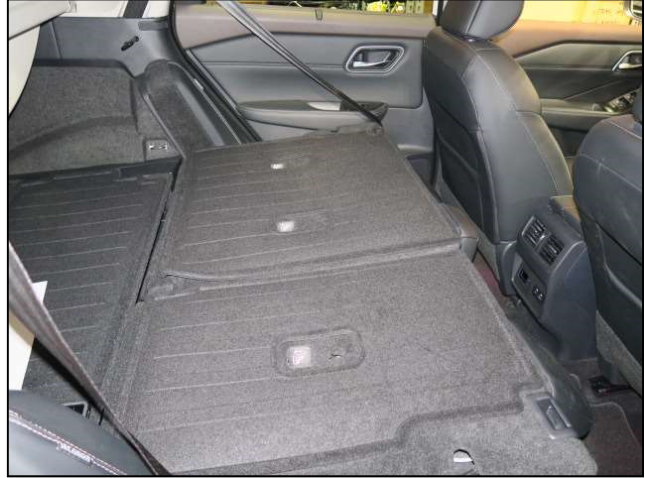
Figure 1

1. Open both rear passenger doors.
2. Lower both rear seat backs.

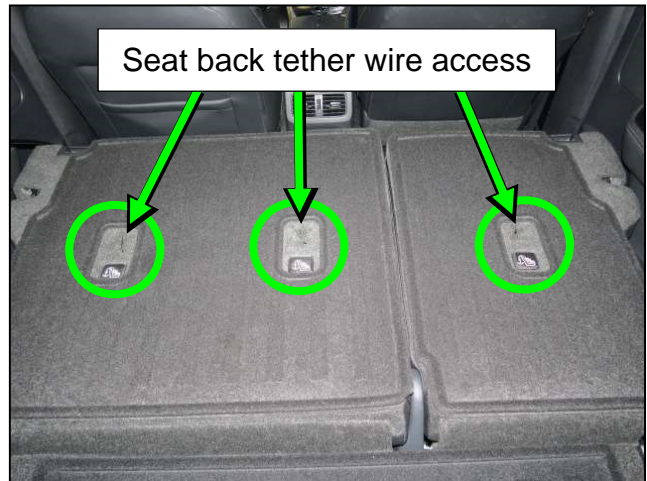
Figure 2

3. Locate the 3 seat back tether wire access holes.
