Campaign No. 2021090008, October 2022  
Revision A July 31<sup>st</sup> 2026

SUBJECT: **Model AMG GT-Class vehicles (190 platform)**  
**Model Year 2016-2018**  
**Check Carbon-Fiber Driveshaft Bonding**

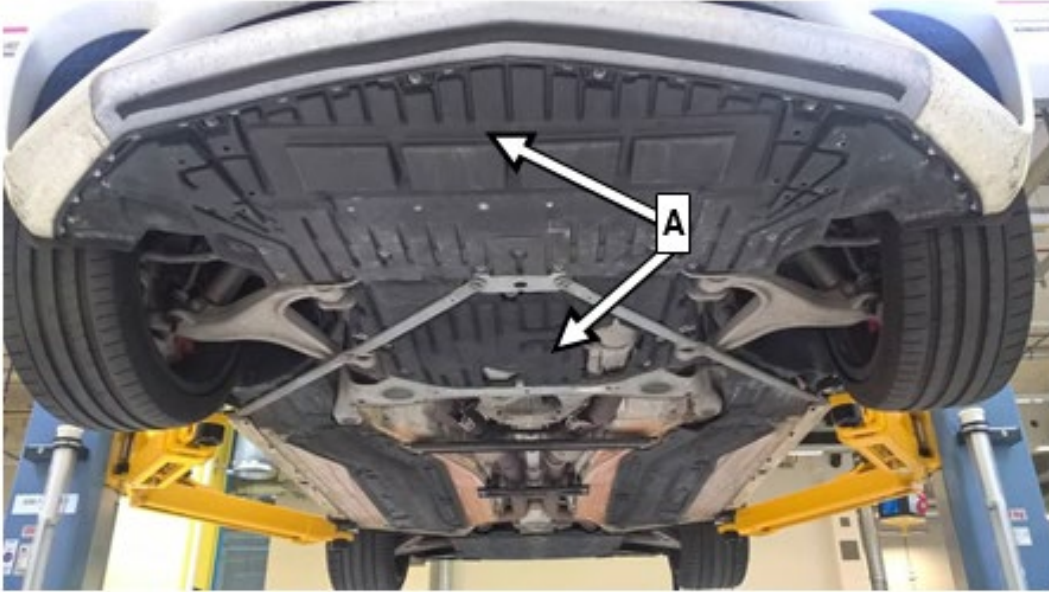
**Figure 1**

1. Remove lower engine compartment lining (A, figure 1).

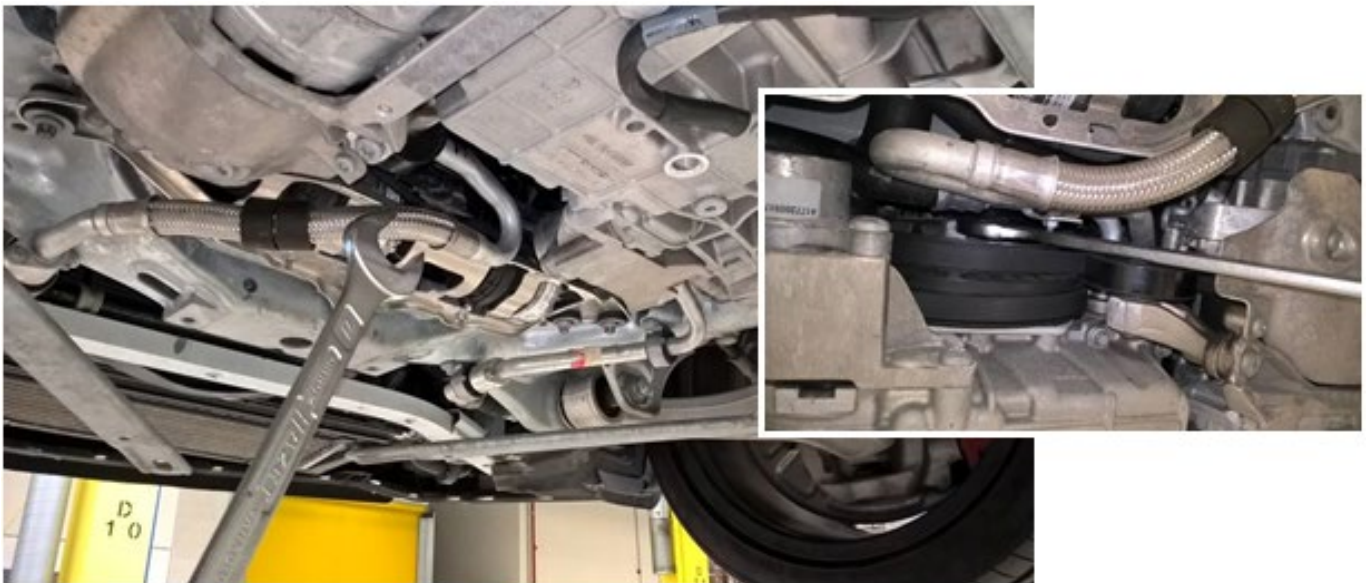
**Figure 2**

2. Open maintenance access on engine-side drive shaft housing.

Rotate engine at center bolt in direction of rotation until affixed label on drive shaft is visible.

**i** Rotate engine at center bolt in direction of rotation with a 27 mm open end wrench.

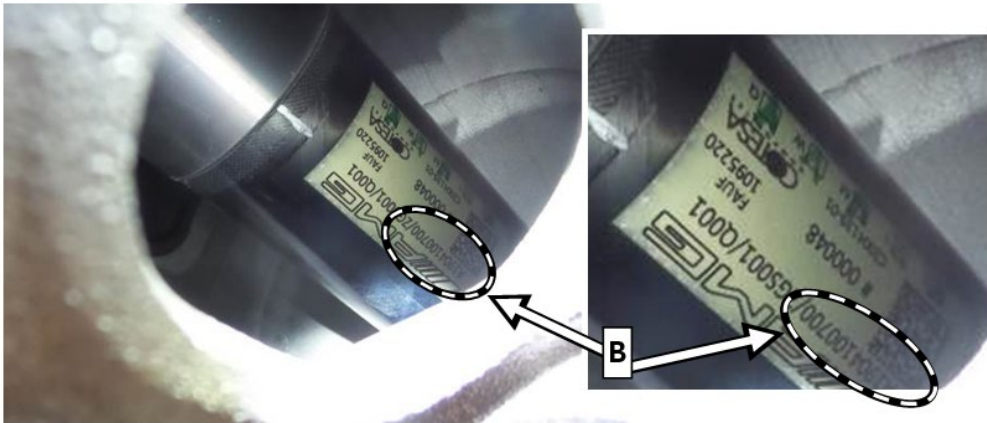
Figure 3

3. Check part item number (**B, figure 3**) of drive shaft.

- a. If part item number is **A 190 410 07 00**:  
Carry out **work procedure**.
- b. If part item number is **A 190 410 06 00** or **A190 410 14 00** or **A 190 410 23 00**:  
**End measure**.

- 1. Replace drive shaft.  
**i** For basic data, see **AR41.10-P-0051MNB**.
