VSR-TSB-032

NHTSA Campaign Number: 21V-482

Subject: ABS System Fuses

Models Affected: Oshkosh S-Series Front Discharge Mixer

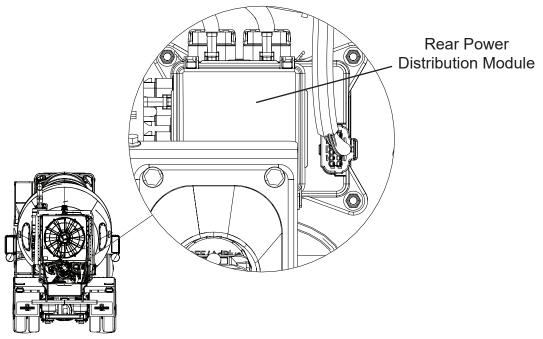
Figure 1

3. Open the engine cover hatch and locate the rear power distribution module, see Figure 1.

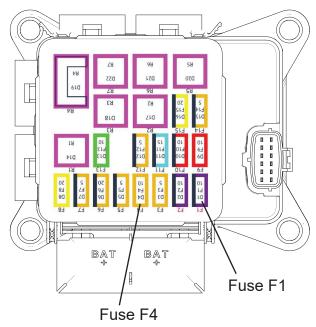
Figure 2

A concern affecting safety exists in some Oshkosh S-Series Front Discharge Mixers. Incorrectly sized ABS system fuses were installed in the rear power distribution module. The ABS system manufacturer is suggesting the 10 amp fuses be replaced with 15 amp fuses for correct modulation of all axles during an active ABS stopping event.

- 4. Remove engine fuse panel cover.
- 5. Remove the 10 amp fuses at position F1 and F4, see Figure 2.
- 6. Install the 15 amp fuses supplied at position F1 and F4, see Figure 2.
