N609NAS1

TECHNICAL BULLETIN

Safety Recall - Front Row Seat Tracks - Renew

MODEL:	MODEL YEAR:	VIN:
Defender (LE)	2021	043374-062024

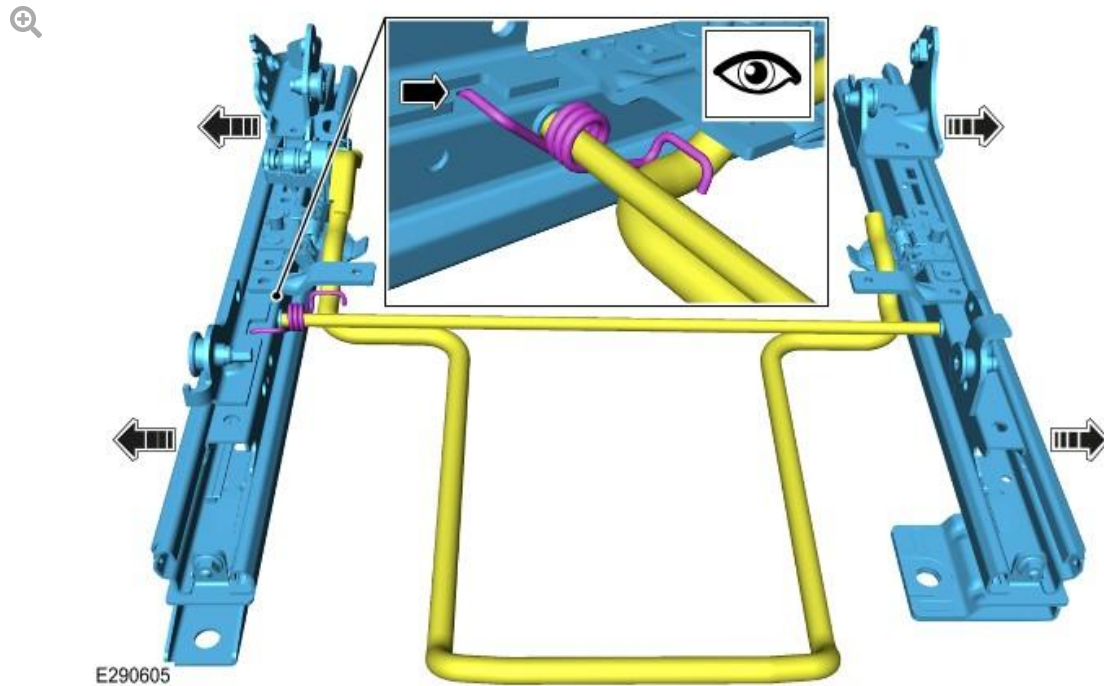
An issue has been identified on certain vehicles within the listed Affected Vehicle Range where the front seat track end stop bracket may become deformed. Deformed seat track end stop brackets may allow the seat to latch further forward than intended by design.

Make a note of the position of the spring and make sure it is installed as shown in the illustration during installation.

Remove and discard both seat tracks.

- Release the spring from the seat track and make sure it is retained with the release handle.
