Campaign No. 2021070033, August 2021

Recall Campaign Bulletin

Check the Side Crash Sensor (Front doors only)

Check airbag pressure sensors in front doors, replace if necessary Models 213, 222, 253, 257, and 290

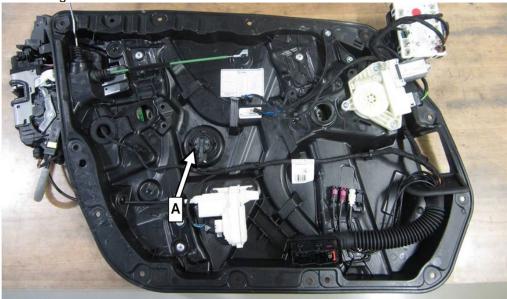
Figure 1, shown on model 213

- 1. Remove door lining on left and right front doors.
 - i For basic data of models 213 and 253, see AR72.10-P-1000LW.
 - i For basic data of model 222, see AR72.10-P-1000LF.
 - $oxed{1}$ For basic data of models **257** and **290**, see **AR72.10-P-6575FR**.
- 2. Disconnect plug from airbag pressure sensors (A, Figure 1) of front doors and check whether two catch tabs (B, Figure 2) are present.
 - i Door modules need *not* be removed.
 - i There must be two catch tabs.
 - i Figure 3 is *not OK*.

- a. Only one catch tab present: Carry out work procedure.
- b. Two catch tabs present: End measure.

1. Replace defective airbag pressure sensor.
