# Product Safety Recall

## N212343883 High Voltage Battery May Melt or Burn

**Release Date:** June 2024  
**Revision Description:** This bulletin is being revised to update the Service Procedure. ZFA – Field Action Multimodule Coordinated Sequence Programming has been removed. Please discard all previous copies of N212343883.  
**Revision:** 02

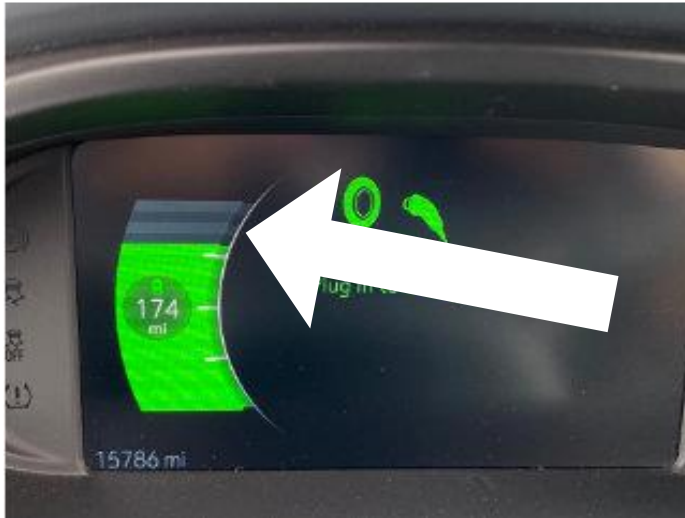
5924268

**Important:** Verify the vehicle SOC is less than 80%. This can be determined by looking at the bars on the power level indicator. If four or more empty bars (not showing green) are displayed, the SOC is at an acceptable level. If the power level indicator shows an SOC of greater than 80% The SOC must be adjusted before proceeding with the recalibration.

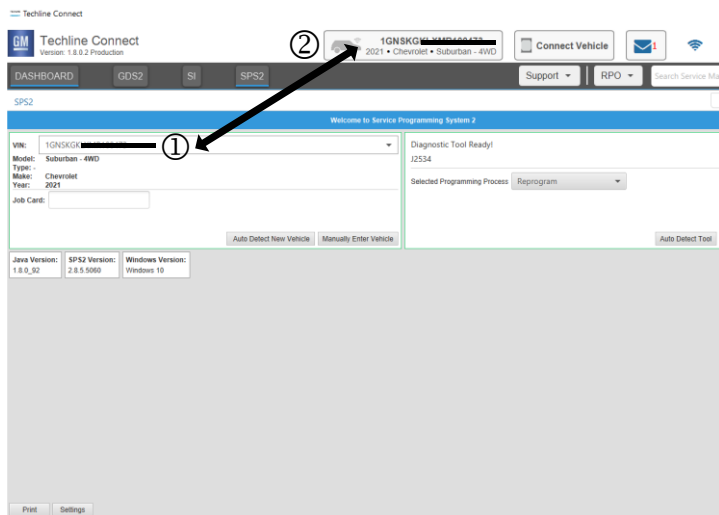
5743643

**Caution:** Be sure the VIN selected in the drop-down menu (1) is the same as the vehicle connected (2) before beginning programming.

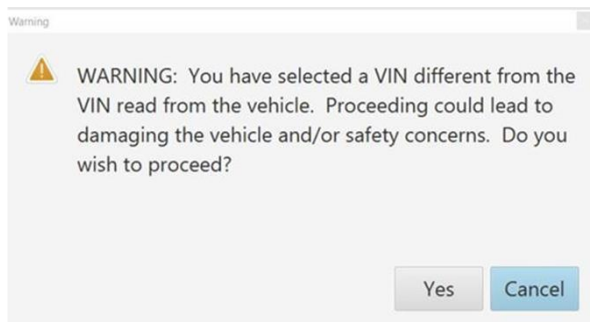
5877000

**Important:** If the vehicle VIN DOES NOT match, the message below will be shown.

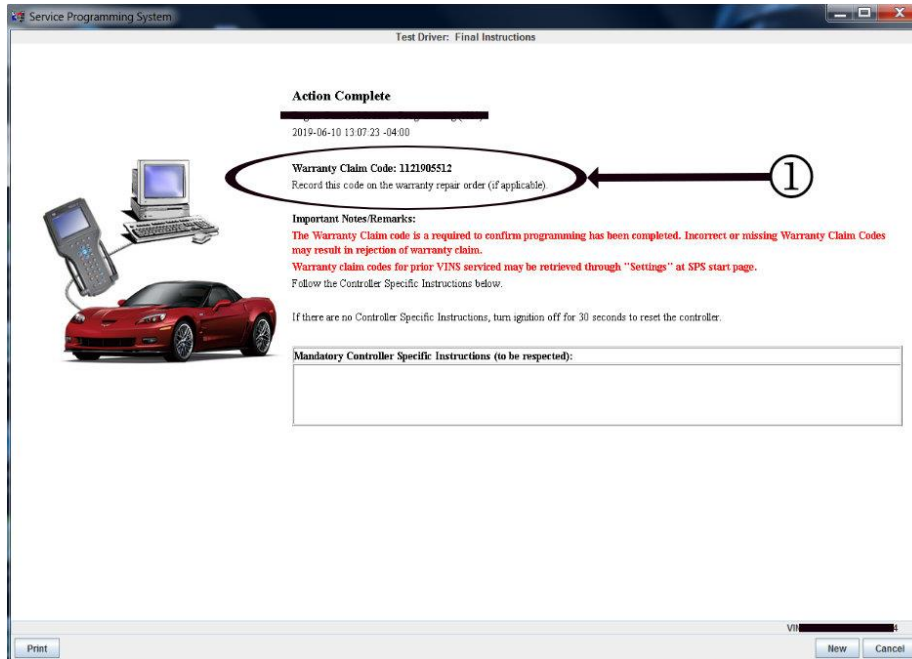
5431209

**Important:** To avoid warranty transaction rejections, you MUST record the warranty claim code provided on the Warranty Claim Code (WCC) screen shown above on the job card. Refer to callout 1 above for the location of the WCC on the screen.
