# SAFETY RECALL

Mack Trucks Inc.  
Greensboro, NC USA

Date	Number	Release	Page
07.2021	SC0427	01	1(5)

## Rear Most Drive Axle Brake Cam Inspection GR, LR, and TE

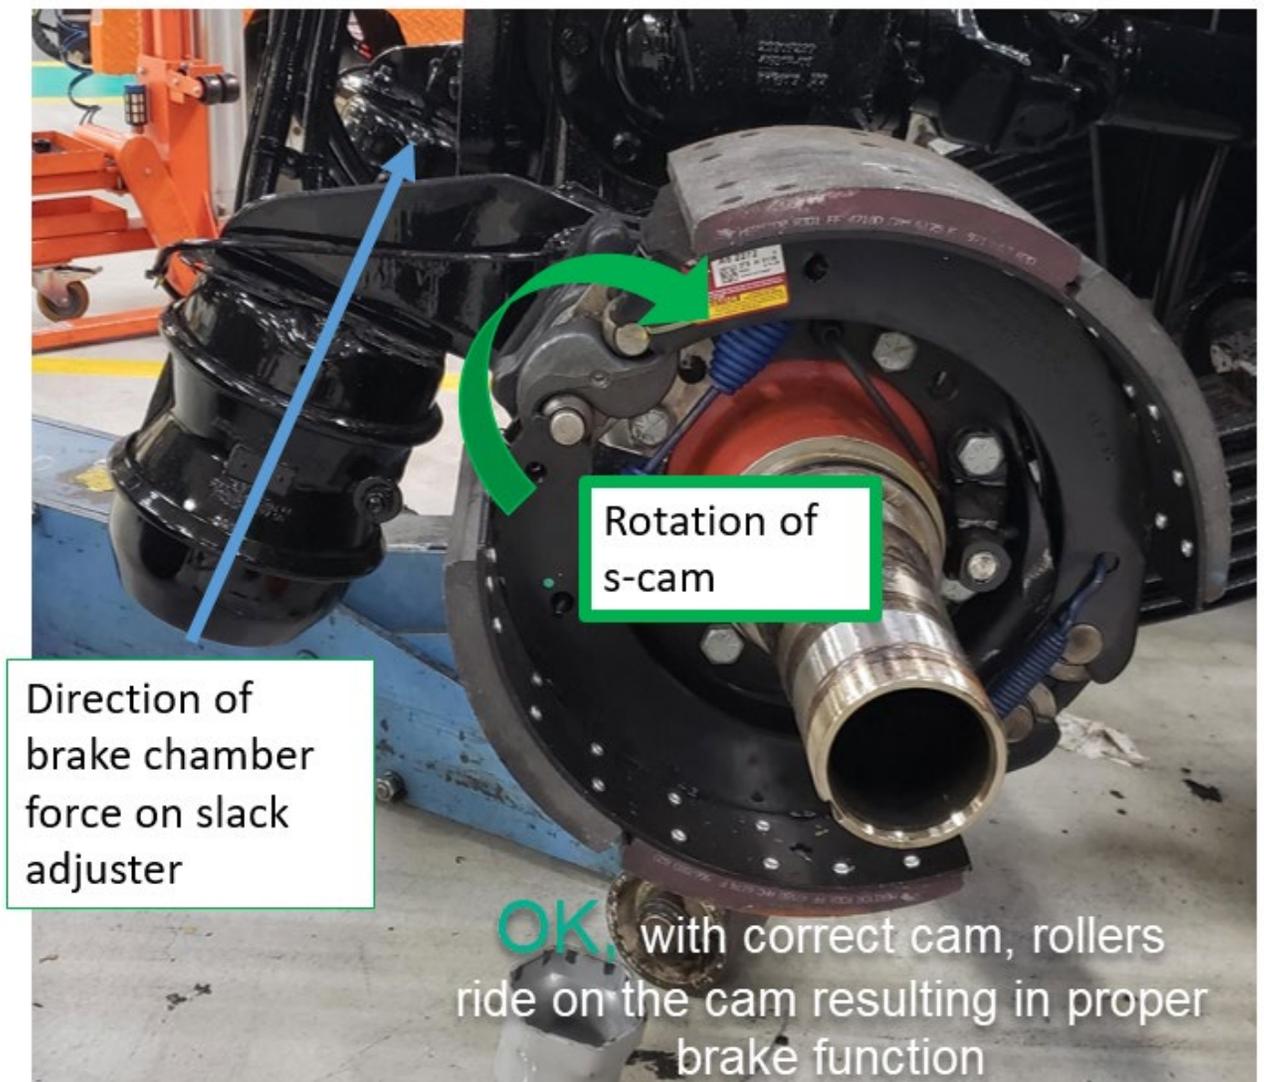
OK (correct brake cam installed)

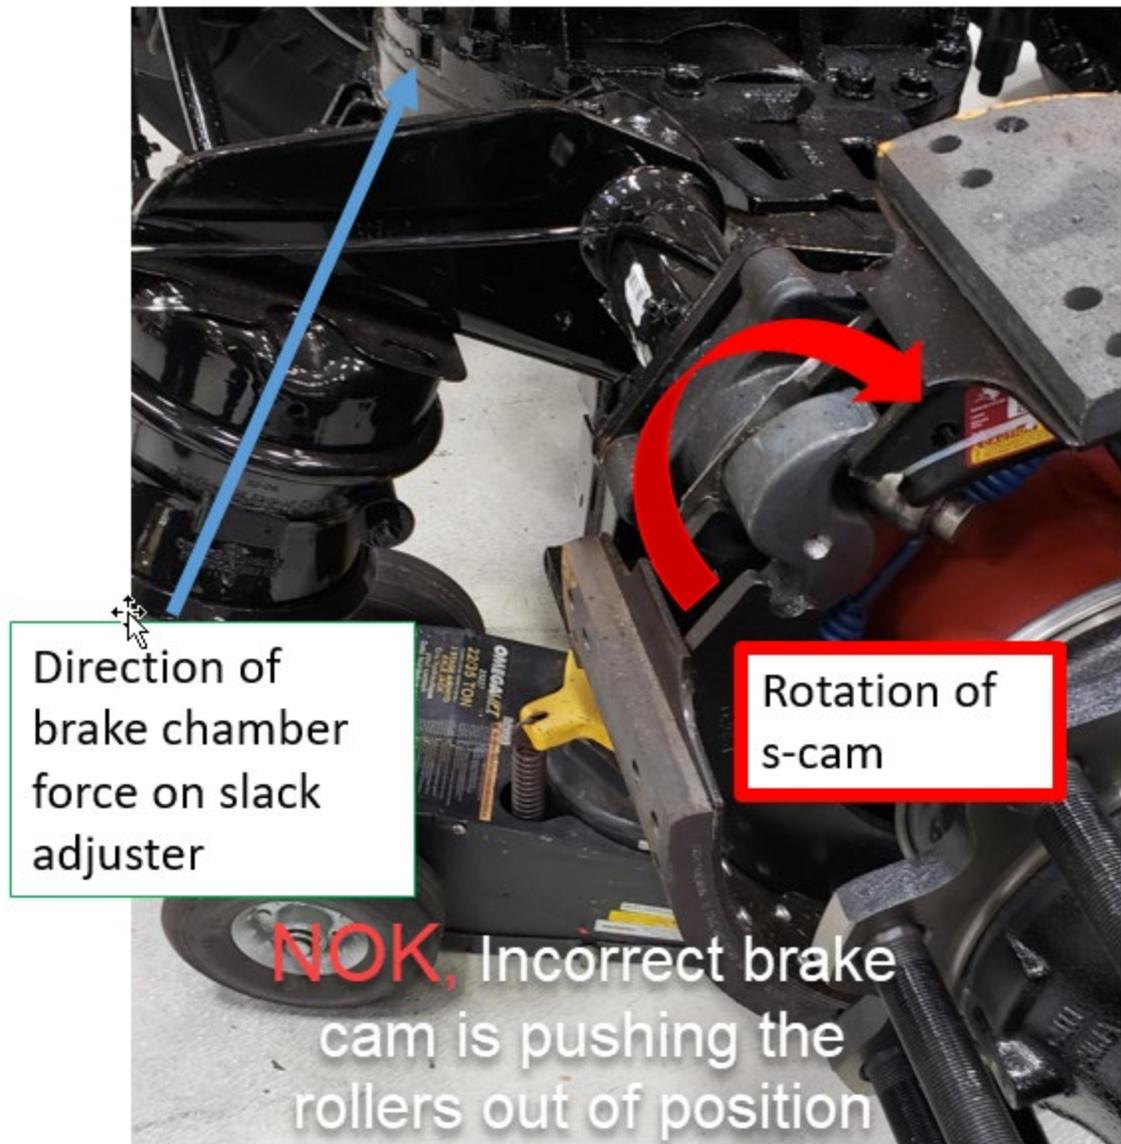
Mack has determined that certain model year 2021 trucks equipped with Meritor drum brakes may have the incorrect brake cams installed on the rear most drive axle.

NOK (incorrect brake cam installed)

4. Remove brake shoes and brake hardware.
  - a. Refer to Meritor Literature on Demand (“LOD”) for proper procedure. The proper Maintenance Manual 4 (“MM4”) can be downloaded free of charge here: <https://www.meritor.com/literature-on-demand>

5. Remove the axle flange nuts and cones on the affected axle.
6. Remove the rear most axle shafts.
7. With axle shafts removed, follow hub removal procedure for PreSet Plus hubs in the Conmet service manual 10084476. Found here: <https://conmet.com/literature/#wheelendlit>

**NOTE:** The correct service manual is located under “Service Manual for ALL Hub Applications”.
8. Remove and replace the affected brake cams using the above Meritor MM4 from the Meritor LOD system.

9. Inspect the brake shoes, Drums, and Brake hardware for reuse. If any defects are found related to the incorrect brake cam being installed, replace with new components. Refer to IMPACT parts tab for current part numbers.

10. Reinstall the brake shoes and the brake hardware referencing the Meritor MM4 service manual.
11. Replace the wheel seal and install the drive hub according to specifications and procedures found in the ConMet service manual referenced above.
