# SAFETY RECALL BULLETIN

SUBJECT:			No: <b>SR-21-007REV2</b>
<b>SEAT BELT AUTOMATIC LOCKING RETRACTOR (ALR) – SAFETY RECALL CAMPAIGN - REVISION</b>			DATE: <b>November 2021</b>
			MODEL: <b>2022 Outlander</b>
<b>CIRCULATE TO:</b>	<input checked="" type="checkbox"/> GENERAL MANAGER	<input checked="" type="checkbox"/> PARTS MANAGER	<input checked="" type="checkbox"/> TECHNICIAN
<input checked="" type="checkbox"/> SERVICE ADVISOR	<input checked="" type="checkbox"/> SERVICE MANAGER	<input checked="" type="checkbox"/> WARRANTY PROCESSOR	<input checked="" type="checkbox"/> SALES MANAGER

This Safety Recall bulletin supersedes SR-21-007REV issued September 2021, to update the Repair Procedure section.

Certain 2022 Outlander vehicles

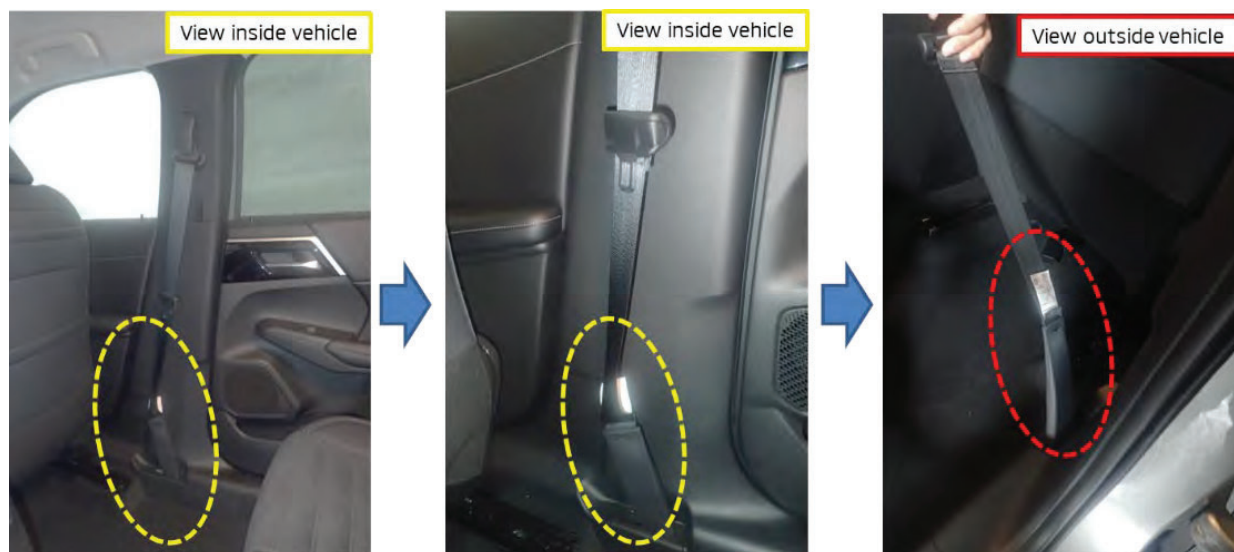
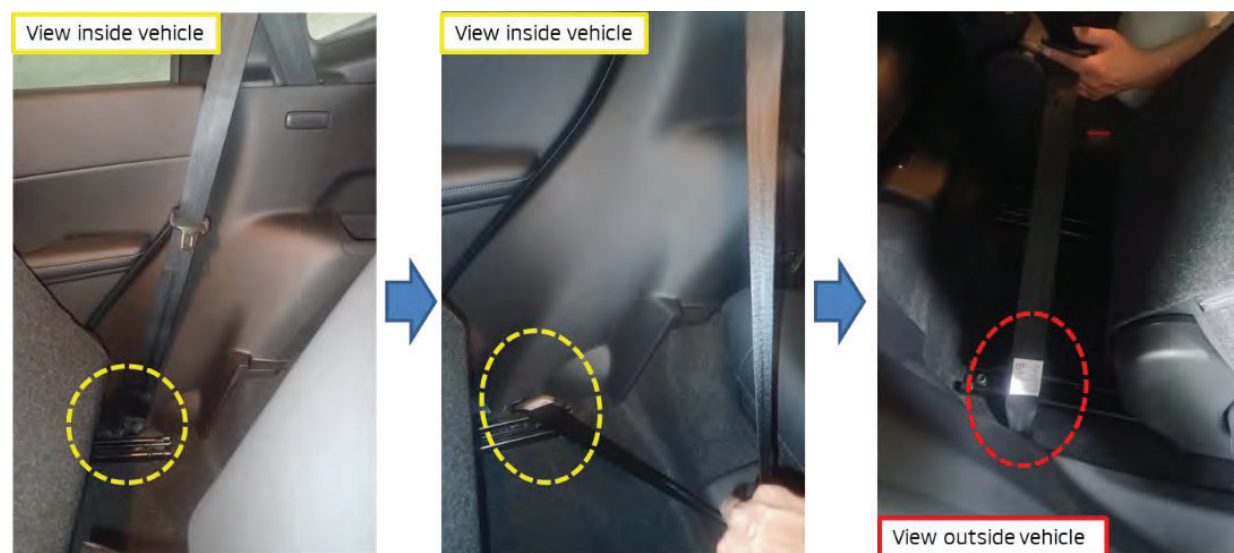
**FIGURE 1: TAG LOCATION**

### 1. SEATBELT TAG PASSENGER SIDE FRONT

### 2. SEATBELT TAG 2<sup>ND</sup> ROW – LEFT AND RIGHT
