# SAFETY RECALL BULLETIN

| SUBJECT: | | | No: <b>SR-21-007REV3</b> |
| <b>SEAT BELT AUTOMATIC LOCKING RETRACTOR (ALR) – SAFETY RECALL CAMPAIGN - REVISION</b> | | | DATE: <b>January 2022</b> |
| | | | MODEL: <b>2022 Outlander</b> |

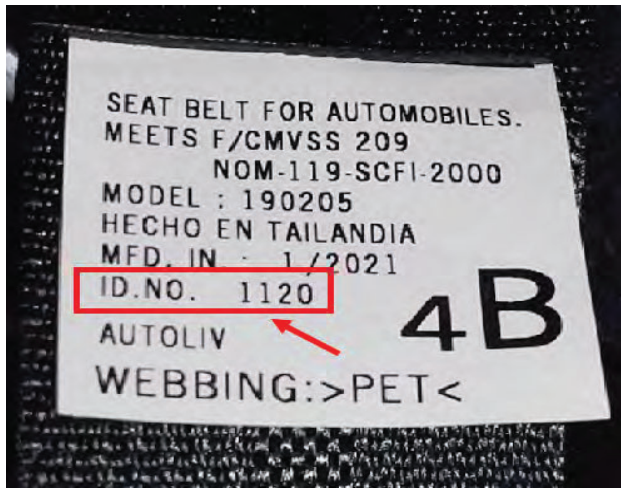
Sample : OK Tag

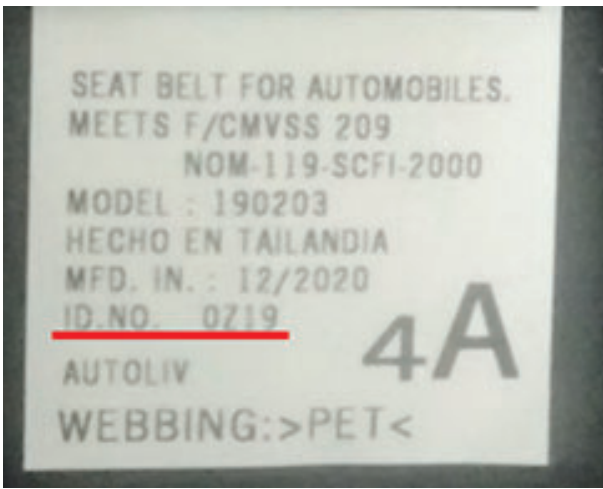
Sample: NG Tag

- **Affected Lot ID. NO. : 0Z19 - 1118**

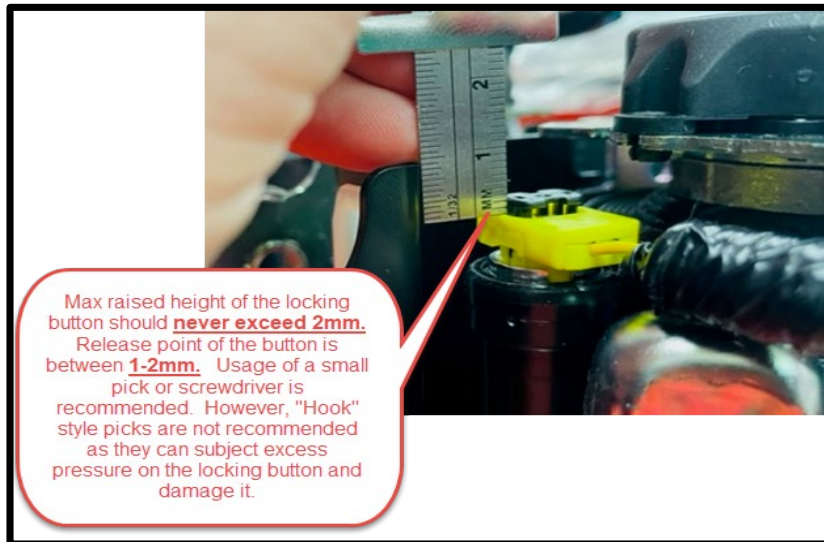
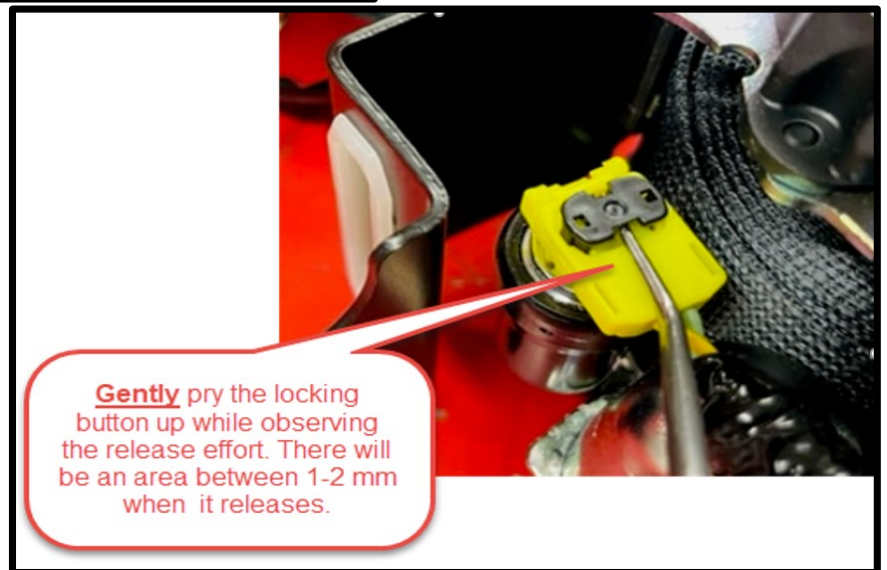
1. Removal process to avoid damage.

Failure to follow proper procedure and applying unnecessary force will damage the connectors. The connectors are not available as a service part and replacement of the entire floor harness will be required. Please use the instructions below for proper removal and installation of the pretensioner connector.

Please use **EXTRA CAUTION** when removing the locking button on the seat belt pre-tensioner connector. The locking button should only be raised approximately 1mm in an upwards direction. This will release the yellow connector body that can now be gently pulled from the pre-tensioner.
