RECALL 21V621, 2021-498 REMEDY INSTRUCTIONS

Make(s): SALEM & WILDWOOD
Model(s): Many
Model Year(s): 2019 - 2021

Concern:
The fresh water tank may not be secured properly.

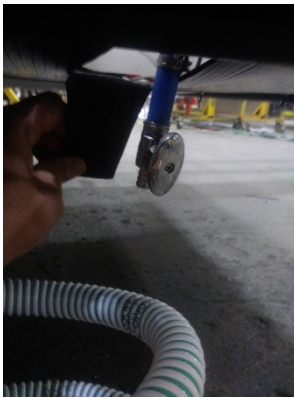
STEP 1: LOCATE THE FRESH TANK DRAIN. IT WILL LOOK LIKE THIS. THE DRAIN LOCATION IDENTIFIES THE LOCATION OF THE FRESH TANK.

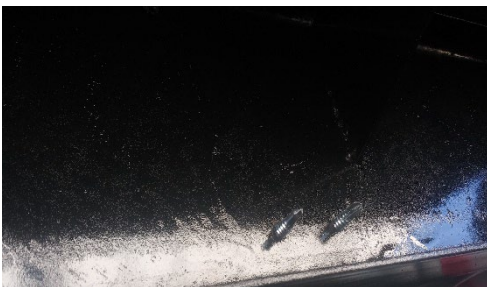
STEP 2: IN SOME MODELS YOU WILL HAVE ONE FOREST INSTALLED TANK BAR ON ONE SIDE OF THE TANK AND A CHASSIS TANK MOUNT ON THE OTHER. SOME MODELS WILL BE TWO TANK BARS, ONE ON EITHER SIDE OF THE TANK. IN EITHER CASE, A TANK BAR SHOULD BE INSTALLED WITH TWO SELF-TAPPING SCREWS COMING THROUGH THE I BEAMS ON BOTH ENDS OF THE TANK BAR. IF INSTALLED CORRECTLY, IT WILL LOOK LIKE THIS ON THE EXTERIOR OF THE I BEAMS. CHECK THE I BEAMS ON BOTH SIDES OF THE UNIT AND VERIFY BOTH ENDS OF EACH TANK BAR WERE SECURED WITH TWO SELF-TAPPING SCREWS AS SHOWN IN THE PICTURE. FOR THE MODELS WITH TWO INSTALLED TANK BARS (ONE ON EACH SIDE OF THE FRESH TANK) YOU WILL NEED TO VERIFY BOTH BARS ARE INSTALLED USING TWO SELF-TAPPING SCREWS ON EITHER END. IF YOU FIND ONE OR MORE OF THE SELF-TAPPING SCREWS ARE NOT INSTALLED, THE UNIT WILL NEED TO HAVE A REPAIR COMPLETED TO AVOID POSSIBLE FAILURE OF THE SECUREMENT.

STEP 1: IF THE TANK BAR OR BARS ARE MISSING SELF TAPPING SCREWS WITH NO EXCESS MOVEMENT OF THE TANK: SELF-TAPPING SCREWS NEED TO BE ADDED FROM THE INSIDE OF THE I BEAM, TO THE EXISTING UNUSED HOLES IN THE TANK BAR FLANGES. ONCE ADDED, THE SECUREMENT SHOULD APPEAR SIMILAR TO THE PICTURES.
