HUSQVARNA TECHNICAL BULLETIN HTB2106

JUNE 25, 2021

RECALL: THIS MODIFICATION HAS TOP PRIORITY AND MUST BE PERFORMED IMMEDIATELY TO ENSURE CUSTOMER SAFETY

CHECKING THE MOUNTING POSITION OF THE LICENSE PLATE HOLDER

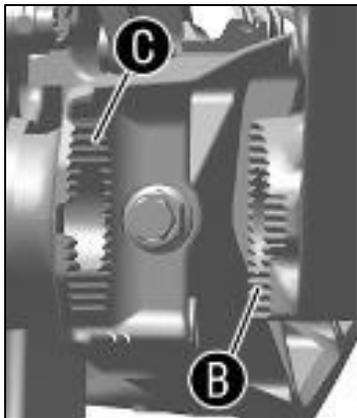
Fig. 1

1. Visually check the alignment of the gear teeth on the license plate carrier (B) and swingarm (C). (Fig. 1-3) to verify that they are aligned with each other.
2. If the alignment of the gear teeth on the license plate carrier (B) and swingarm (C) **is correct** as shown in Fig. 2 then retighten rear wheel axle collar nut to 90 Nm to complete the inspection.
3. If the alignment of the gear teeth on the license plate carrier (B) and swingarm (C) **is incorrect** as shown in Fig. 3 then loosen the components and align the gear teeth on the license plate carrier (B) and swingarm (C) correctly.
4. Retighten the rear wheel axle collar nut to 90 Nm to complete the repair.
