SAFETY RELATED RECALL

Global Recall Action
Number: N623v2

Subject: Gasoline Fuel Tank Flange Assembly Cracking	Publication No.: N623v2
	Model: Discovery 4 / LR4 (LA)
	Model Year: 2010 - 2016
	Model: Range Rover Sport (LS)
	Model Year: 2010 - 2013
	Date of Issue: 27 June 2022

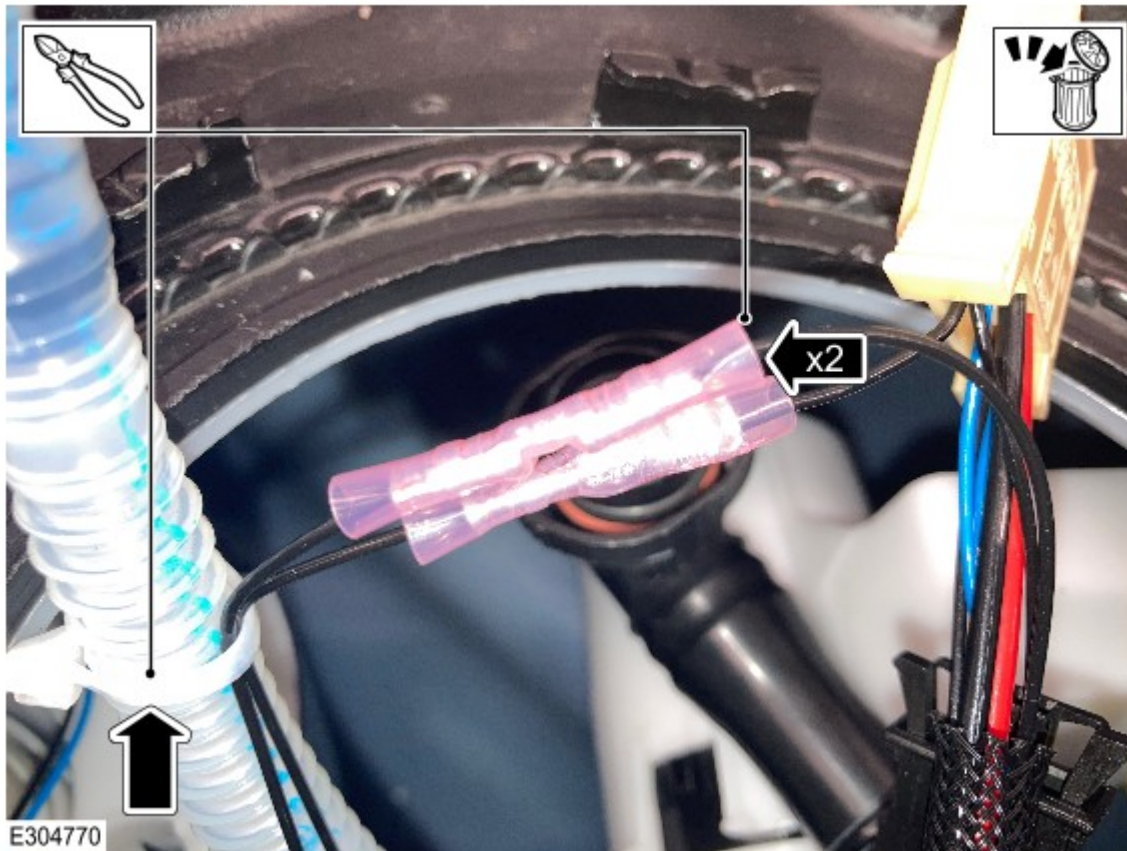
1.

CAUTION: If the 2 splice connectors shown in the illustration are installed, they must be removed and discarded. The wires must be cut as close to the splice connectors as possible.

The instructions provided within the SERVICE INSTRUCTION section below will vary for vehicles which have previously had Technical Bulletin LTB00566 completed. Up to 3, black 2-pin electrical connectors will have previously been removed and discarded during completion of LTB00566, and instead, splice connectors will have been installed. The 2 splice connectors shown in the illustration secure the existing fuel tank flange assembly ground wires to the fuel pump driver module wiring harness. The 2 splice connectors along with the 1 cable tie also shown in the illustration will require removing and discarding to allow the existing fuel tank flange assembly to be removed and discarded.
