Release Date:	June 2023		Revision:	00
Attention:	vehicle equip		ler to deliver a new motor vehi overed by this notification unde		
		olved in this recall were p oulletin contains the final	laced on stop delivery in safet remedy.	ty recall N21	2345940 on August 20,
		ed for demonstration pur	er inventory must be held and boses until the repair contained		
	This safety i N212345940.		the final remedy for VINs of	originally rel	eased in safety recall
	of vehicle re	eturn or delivery. This v return to a maximum s	alers will review the Notice to notice contains the approxim tate-of-charge of 100%. Plac	ate miles of	f when the battery will
			tice to Customer must be prove notice in the glove compartm		plained to the customer
	action-specifi		eted by Chevrolet EV certified ment requirements, and repair equired training.		
	Agreement ar requirements	nd have met all the Chev	t Dealers who have signed the rrolet Bolt EV/EUV-specific trai the repair. Any Dealer unsure Service Manager.	ining, tools, a	and equipment

Safety Recall

N212345944 High Voltage Battery May Melt or Burn

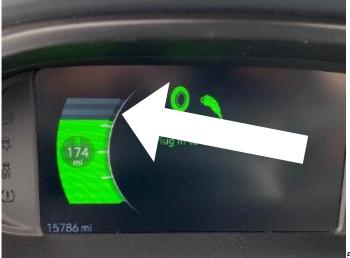
5924268

Important: Verify the vehicle SOC is less than 80%. This can be determined by looking at the bars on the power level indicator. If four or more empty bars (not showing green) are displayed, the SOC is at an acceptable level. If the power level indicator shows an SOC of greater than 80% The SOC must be adjusted before proceeding with the recalibration.

If required, reduce the SOC as follows:

- Vehicle in PARK, Vehicle ON.
- Headlamps Low Beam: ON.
- Temp Control: Hi (Max Heat High) (note: windows should be down).
- Distribution: MAX Defrost (Engages AC Compressor).
- Fan Speed: High (8).
- Select: Fresh Air (Not recirc).

- Select: Heat & A/C.
- If equipped, turn heated seats to hi position.
- Verify SOC after 60 minutes. If the SOC is still greater than 80%, allow additional time for the loads listed above to reduce the SOC to less than 80%.
- When the SOC adjustment is completed return the HVAC controls to 72 Deg. AUTO, Set the headlamp control to AUTO.
