PRODUCT CAMPAIGN BULLETIN

APPLICABILITY: 2021 MY Impreza

NUMBER: WRI-21

SUBJECT: Left Front Lower Control Arm Improper Weld

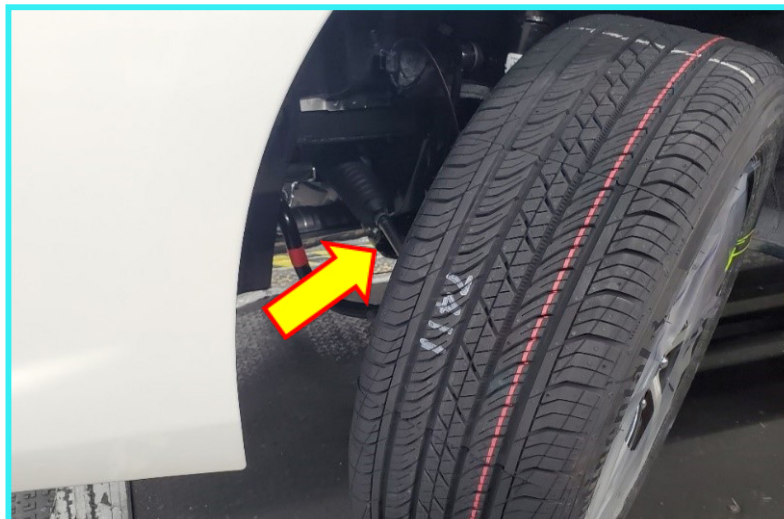
STEP 1): Turn the steering wheel to the left full lock position and view behind the tire.

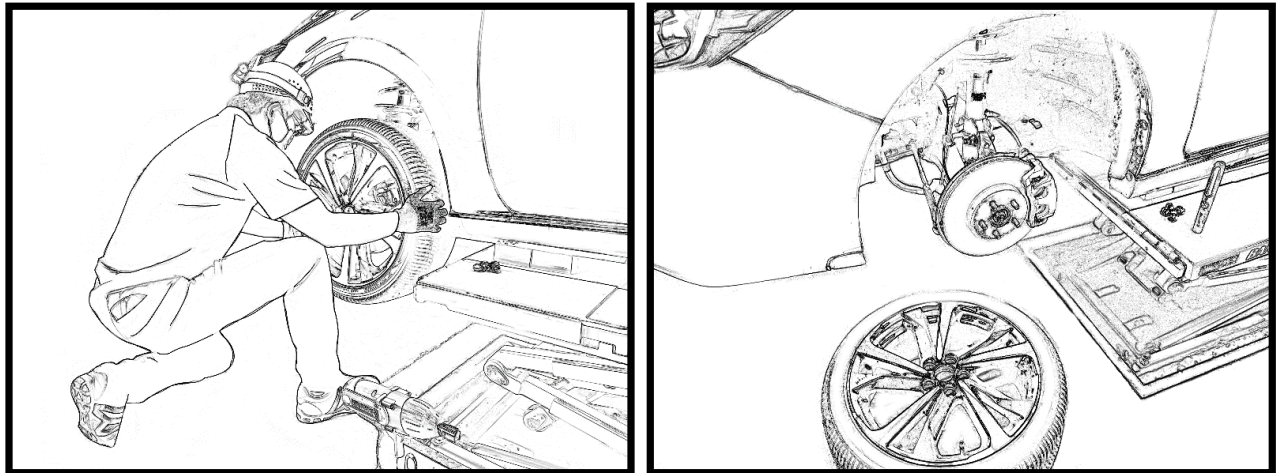
STEP 1): Lift vehicle and remove the left front wheel.
