PRODUCT CAMPAIGN BULLETIN

APPLICABILITY: 2021 MY Impreza

NUMBER: WRI-21R

SUBJECT: Left Front Lower Control Arm Improper Weld

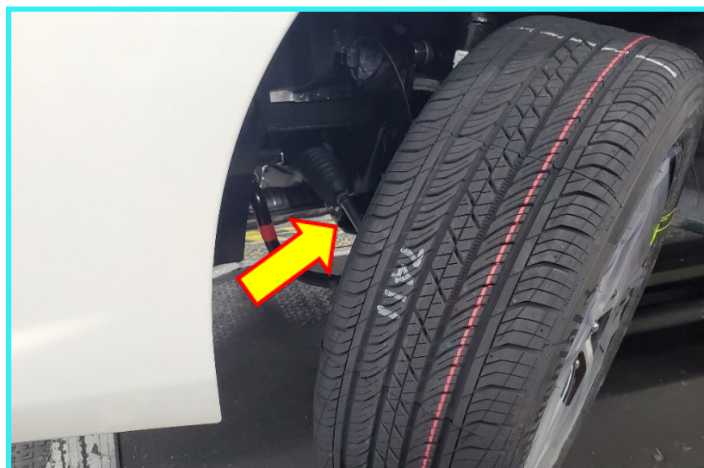
STEP 1): Turn the steering wheel to the left full lock position and view behind the tire.

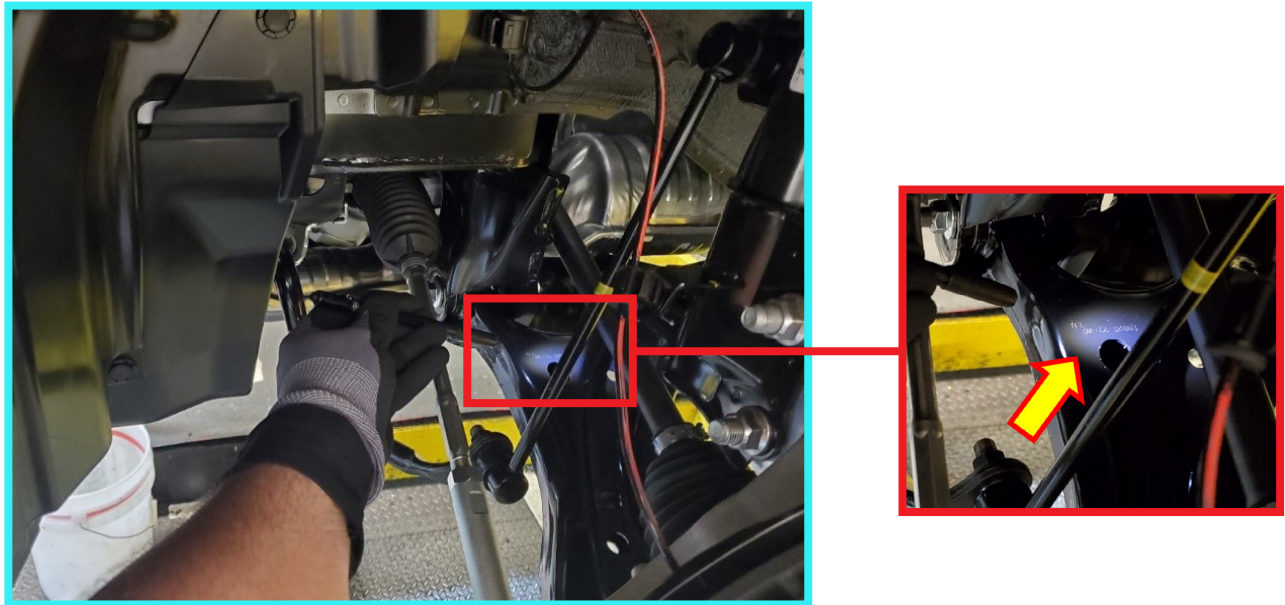
STEP 2): Locate the LOT Number stamped the on top section of the arm.

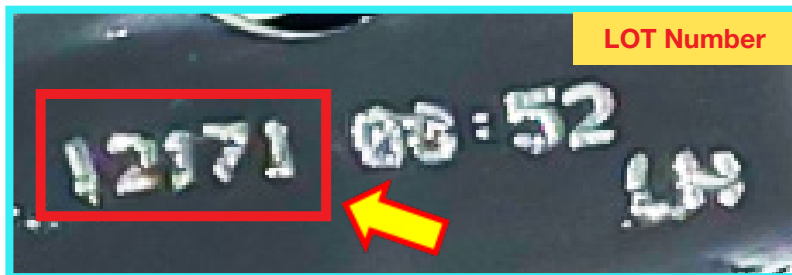
STEP 3): Clean the top of the front lower control arm with a damp cloth to provide increased visibility of the stamped Lot Number. Verify and record the LOT Number with a photograph and document the LOT number on the repair order. A photograph can be taken with the wheel in the left full lock position.

EXAMPLE:
LOT Number **12171** is shown

YES: The left front lower control arm is “Not Good” and **MUST** be replaced.
Refer to **STEP 5**.

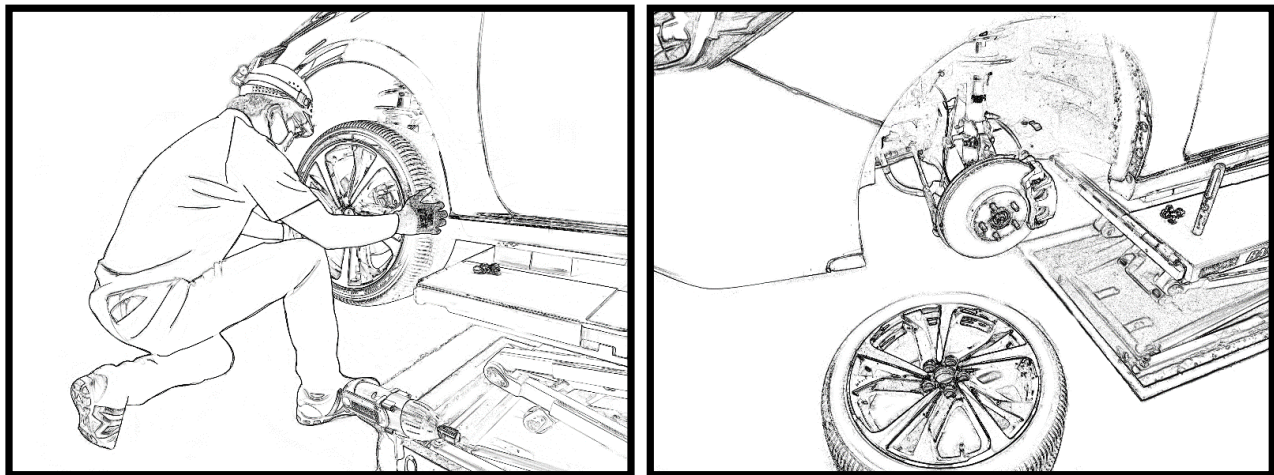
STEP 1): Lift vehicle and remove the left front wheel.

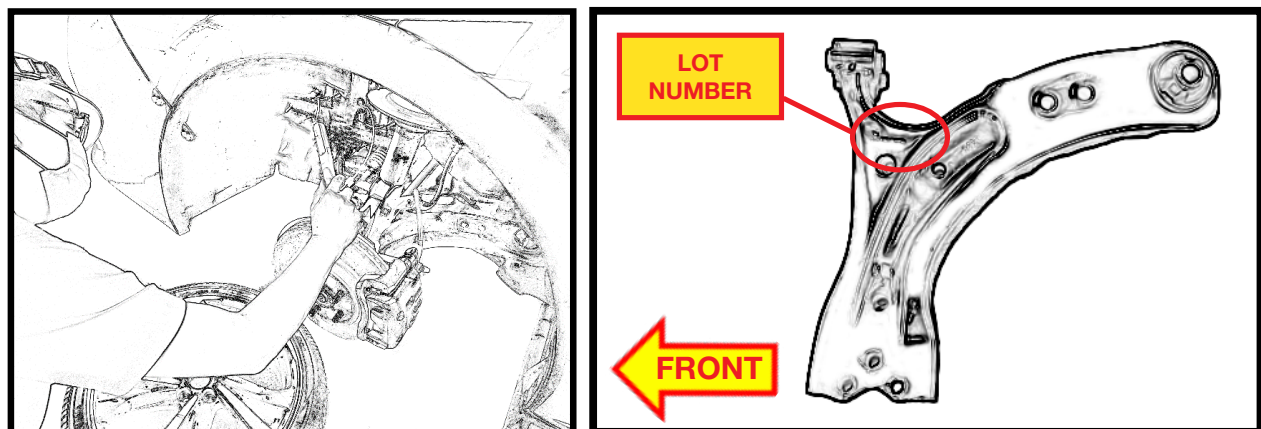
STEP 2): Clean the top of the front lower control arm with a damp cloth to provide increased visibility of the stamped LOT Number.

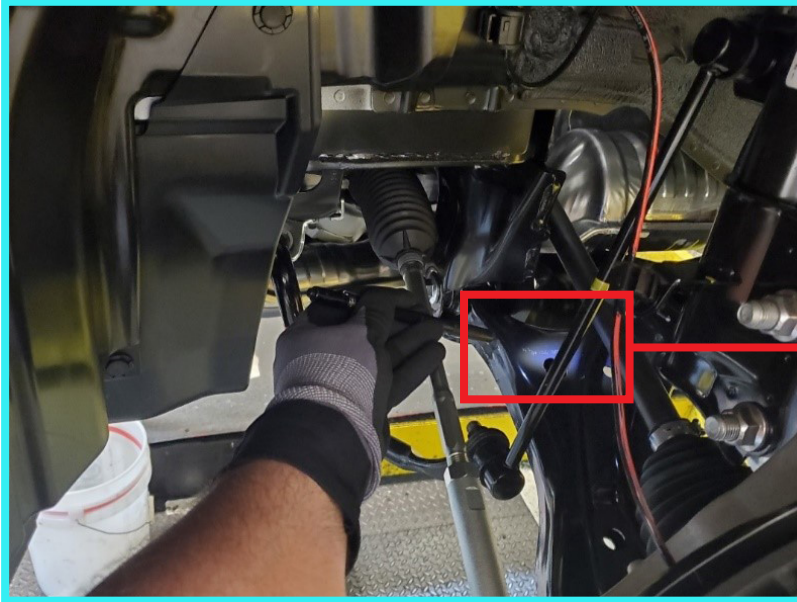
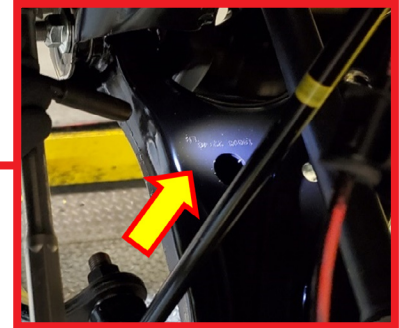
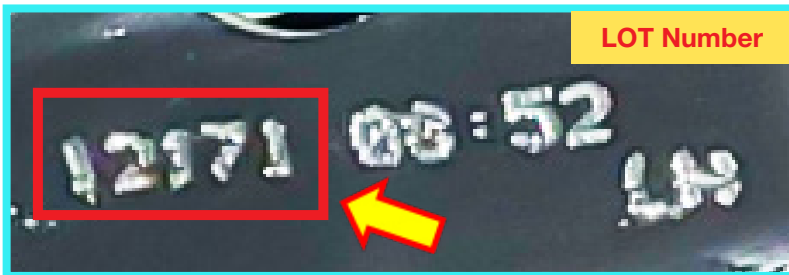
STEP 3): Illuminate the stamped LOT Number on the left front lower control arm. Capture the 5 digit Lot Number with a photograph and document the LOT number on the repair order.

EXAMPLE:
LOT Number **12171** is shown

YES: The left front lower control arm is “Not Good” and **MUST** be replaced. Refer to **STEP 5**.

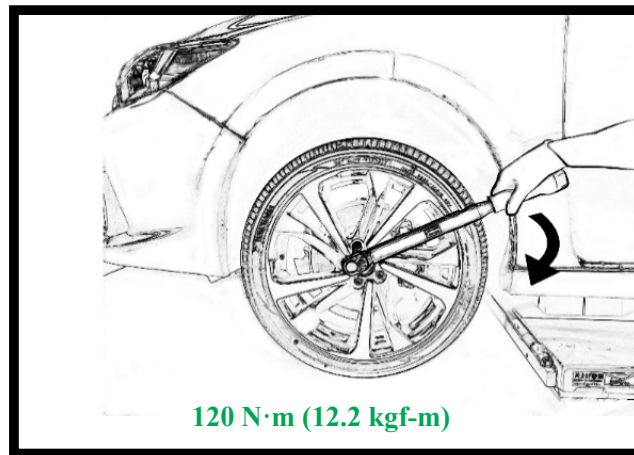
- Tightening Torque for Wheels: **120 N·m (12.2 kgf-m)**

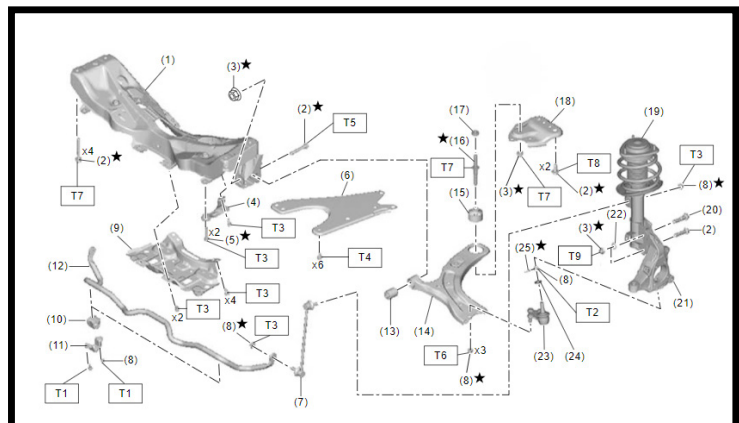
- The Service Manual uses a **black star (★)** in the component breakdown illustrations to indicate one-time use parts. Refer to the image posted to the right.
