Safety Recall

Date	Number	Release	Page
09.2021	SC0429	01	1(7)

Brake Pedal Inspection MD6 and MD7

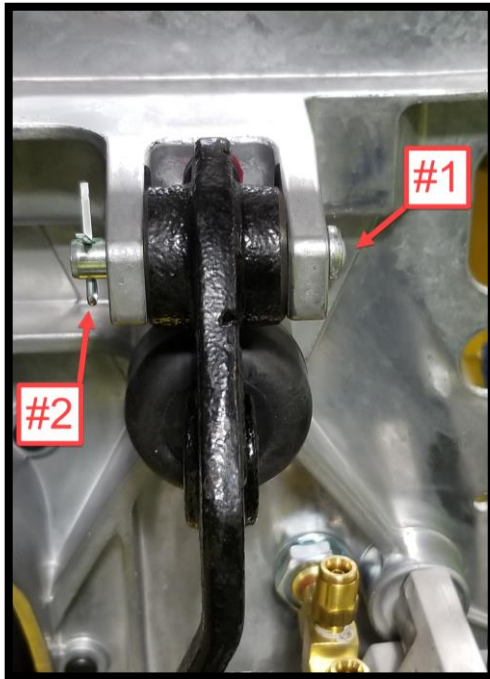
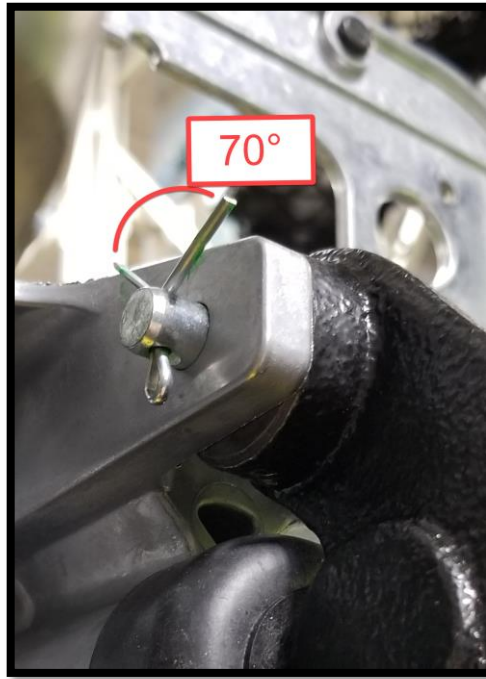
12. Inspect the service brake pedal hardware, Clevis Pin (#1) and Split Pin (#2), for proper installation.

- a. If incorrect installation, missing hardware, or the split pin not adequately spread is found report this quality issue; by open an **E-Service Case to Reliability Department** using the **Recall Number SC0429** in the title. A picture of the quality issue found is required.
- b. If installation of brake pedal is correct, continue with reassemble. No E-Service to Reliability is needed.

13. Replace any missing hardware and ensure the Split Pin (#2) is spread to 70 degrees (as seen in image above).
14. Install the panel.
