RECALL CAMPAIGN BULLETIN

Classification: BT21-014	Reference: NTB21-084	Date: September 13, 2021
-----------------------------	-------------------------	-----------------------------

VOLUNTARY SAFETY RECALL CAMPAIGN 2022 PATHFINDER; SECONDARY HOOD LATCH BRACKET

CAMPAIGN ID #: PC840
APPLIED VEHICLES: 2022 Pathfinder (R53)

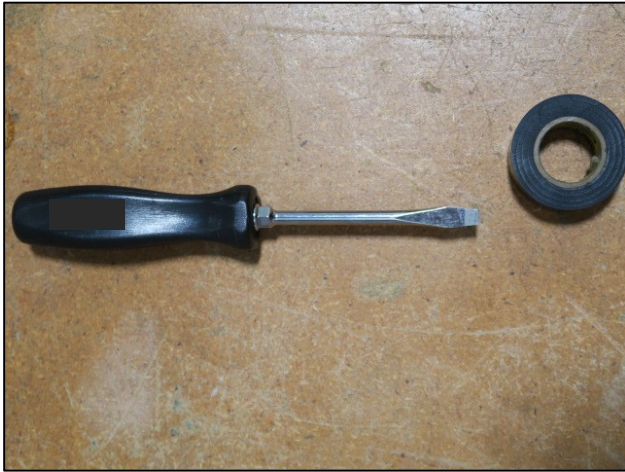
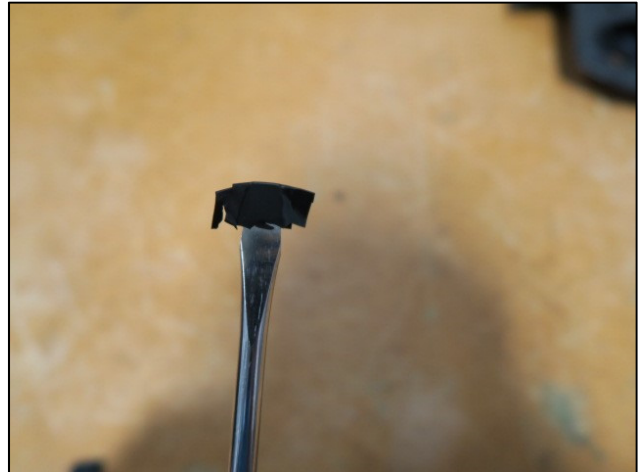
1. Place two (2) layers of electrical tape over the tip of a flat-blade screwdriver (Figure 1 and Figure 2).

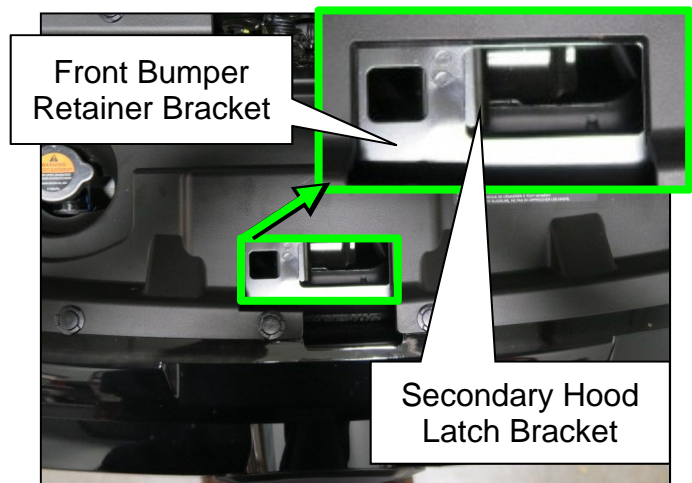
Figure 3

2. Open the vehicle's hood.
3. Locate the Secondary Hood Latch Bracket that is welded to the Front Bumper Retainer Bracket.

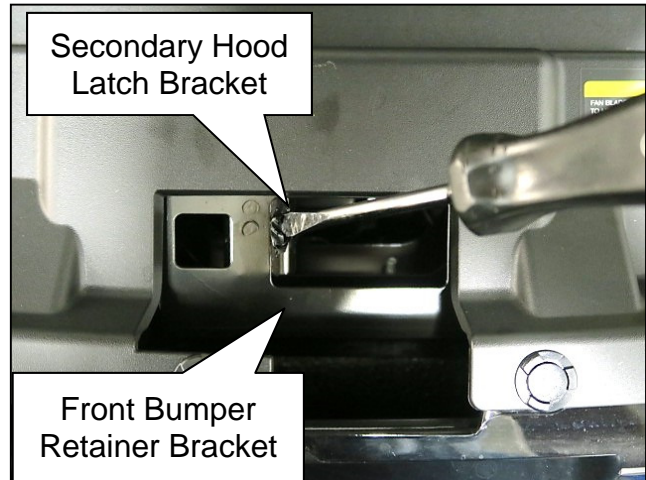
Figure 4

4. Place the tape covered flat-blade screwdriver onto the Secondary Hood Latch Bracket at a 45° angle, as shown in Figure 4.

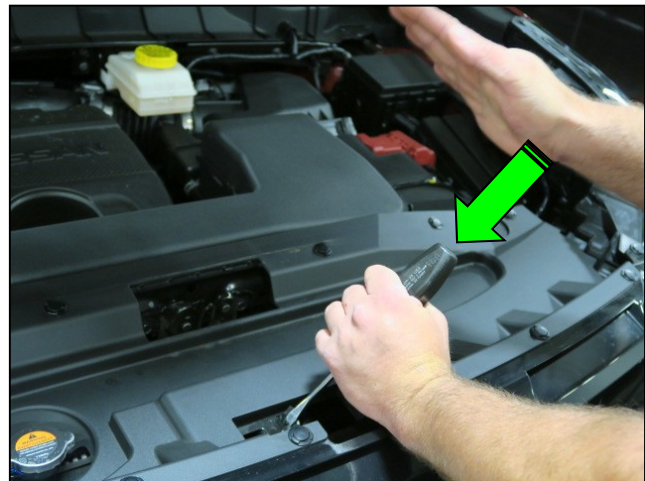
Figure 5

5. Using the palm of your hand, tap on the end of the screwdriver handle 3-5 times, using moderate pressure.

- If the Secondary Hood Latch Bracket became detached from the Front Bumper Retainer Bracket, proceed to step 6 on page 4.
- If the Secondary Hood Latch Bracket did not detach from the Front Bumper Retainer Bracket, no further action is required. Proceed to **CLAIMS INFORMATION** on page 8.
