Safety Recall Code: 51H5

Subject	Roof Reinforcement				
Release Date	November 19, 2021				
Affected Vehicles	Country	Beginning Model Year	Ending Model Year	Vehicle	Vehicle Count
	USA	2018	2018	TIGUAN LWB	2
	CAN	2018	2018	TIGUAN LWB	1
				ay of repair to verify that a VIN nquiry & verification source.	l qualifies for repair
	✓ Campaign status must show "open."				
	 If ELSA shows other open action(s), inform your customer so that the work can also be completed at the same time the vehicle is in the workshop for this campaign. 				
Problem Description	Vehicles included in this recall may have been repaired after having sustained roof damage with an unapproved roof reinforcement replacement part.				
	If the vehicle was repaired with an incorrect roof reinforcement replacement part, there is the risk that, in the event of a severe crash, the roof frame deformation could be higher and the functionality of the restraint systems, such as head curtain airbags, can be influenced. This may lead to the increased risk of injury to vehicle occupants in the event of a severe crash.

Subject: Safety Recall 51H5 - Roof Reinforcement

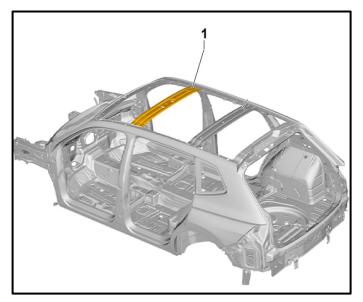
• Replacing roof reinforcement <1> also requires replacing the roof.

• Work with your preferred body shop to have the repairs completed.
